Alannah Duffy  
Environmental Officer  
Noosa Shire Council  
PO Box 141  
TEWANTIN QLD 4565

19 February 2020

**RE: Noosa Oyster Reef Restoration – 2<sup>nd</sup> Annual Monitoring Report 2019**

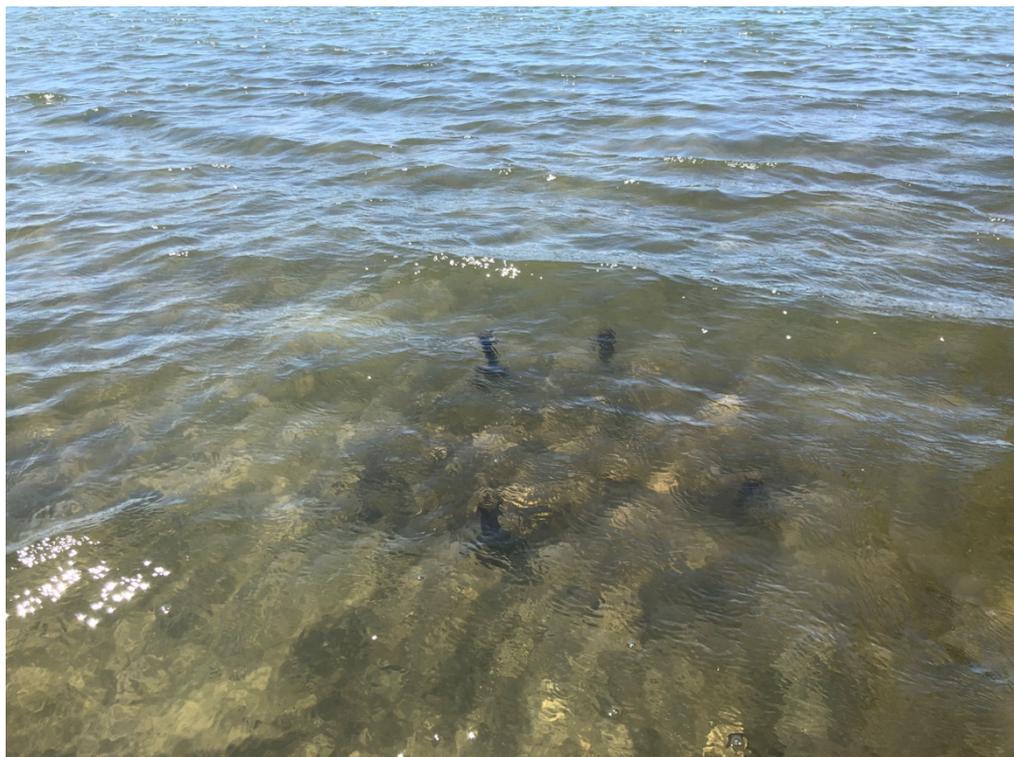
Restoration units have largely settled into the unconsolidated sandy substrate. The reefs have not moved substantially from their original deployment position; however, the coir mesh has lost strength, broken apart in places and degraded to the point where it is not possible to restitch the bags by hand. The degradation of the bags has released some shell (although oyster shell had moved less than 0.5 m from the original position in October 2019). Fine sediment has surrounded and buried much of the remaining shell in bags at this site and they have lost height due to the collapse of the top bags. It was not possible to repair the bags due to degradation of the coir mesh.

Figure 2 Oyster reef and wooden stakes at Site 12 in October 2019

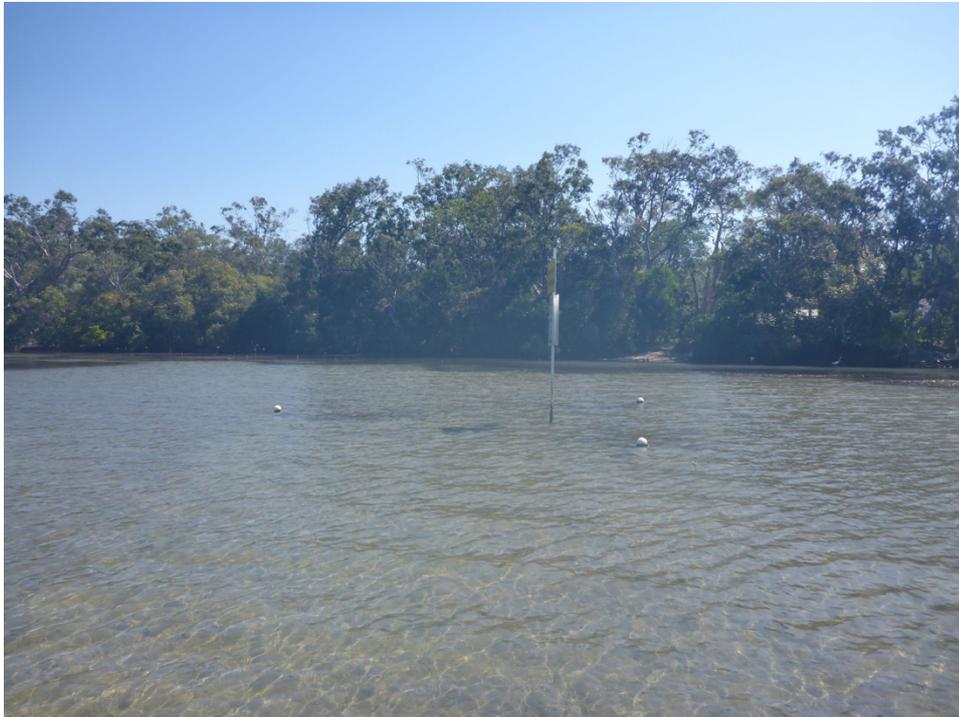
Restoration units have settled into the unconsolidated sandy substrate. Restoration units have lost substantial vertical relief and in October 2019 were only approximately 10 to 15 cm above the surrounding substrate surface. Oyster shell remains largely intact at the site (Figure 3) (moving less than 0.5 m) despite the coir bags degrading to the point where it is no longer possible to repair the mesh by hand.

Figure 3 Oyster reefs at Site 13.

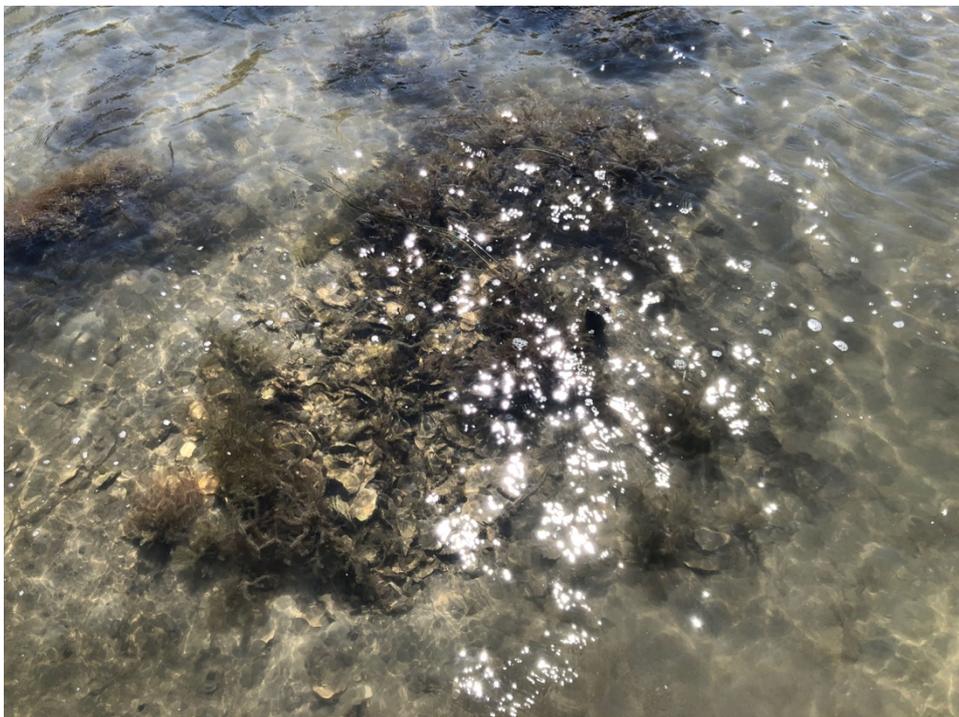
Figure 4 Oyster reef with high coverage of macroalgae at Site 13

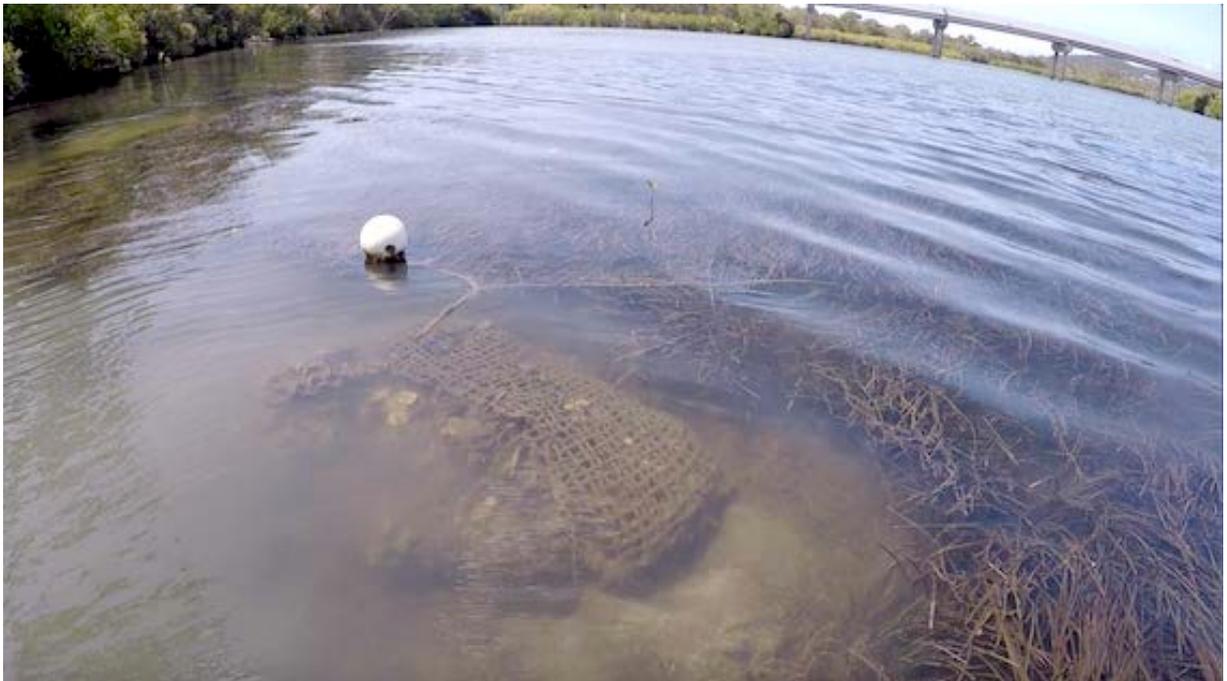
Restoration units have largely been consolidated by foliose macroalgae (Figure 4). The restoration units at this site are surrounded by established seagrass beds (dense, long bladed *Zostera mulleri*), which have increased in extent since deployment, particularly closing gaps over bare sediment around the restoration units (Figure 4, Figure 5 & refer to Table 4). Numerous juvenile fish were observed using the reef restoration units and moving between them and the surrounding seagrass in both April and October 2019 (Figure 7).

Figure 5 Oyster restoration unit at Site 14 in May 2019

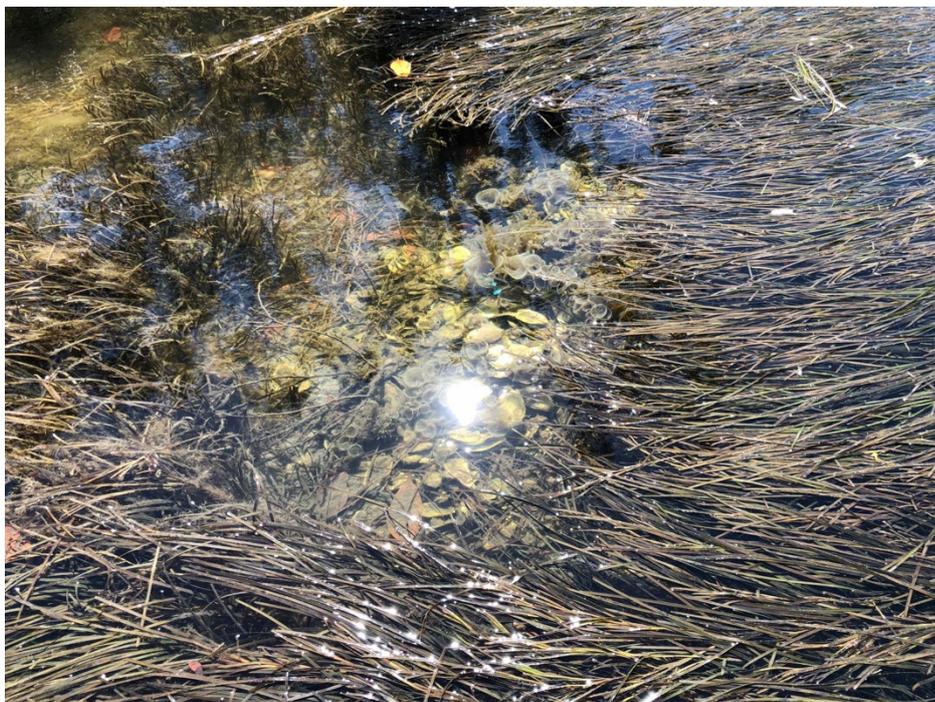
Figure 6 Oyster reef at Site 14 covered with *Padina* and surrounded by dense seagrass and seagrass wrack in October 2019

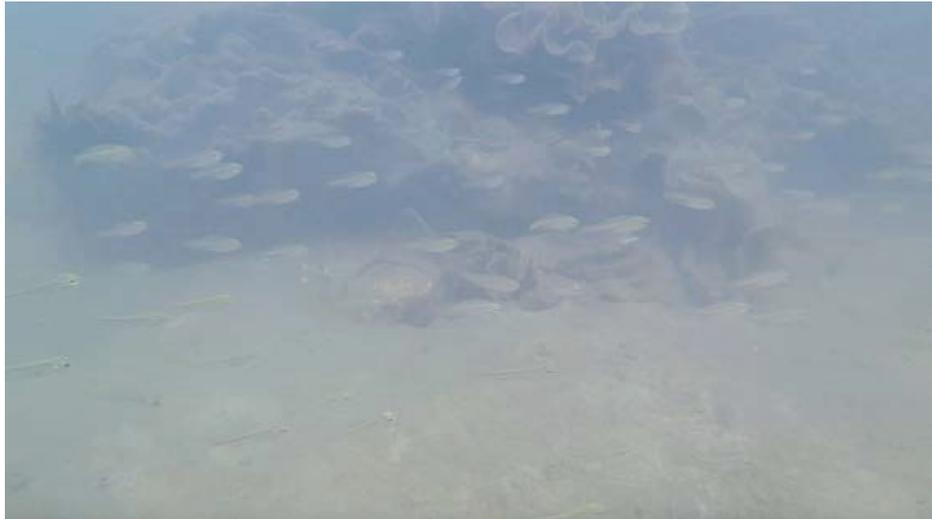
Figure 7 Juvenile fish schooling around oyster reefs at Site 14

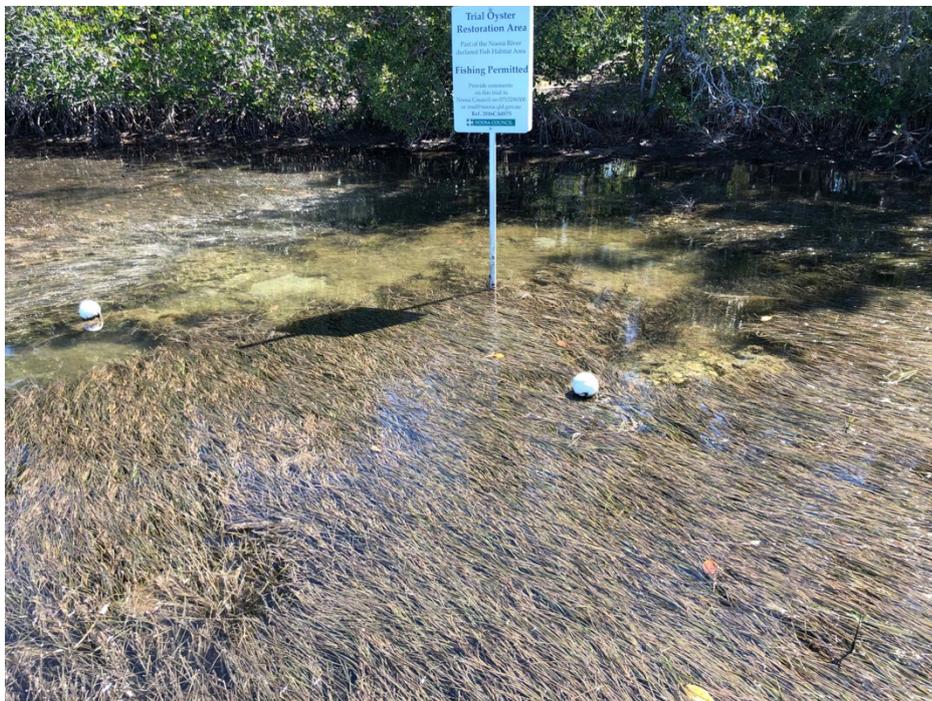
Figure 8 Dense seagrass and restoration units at Site 14 in October 2019

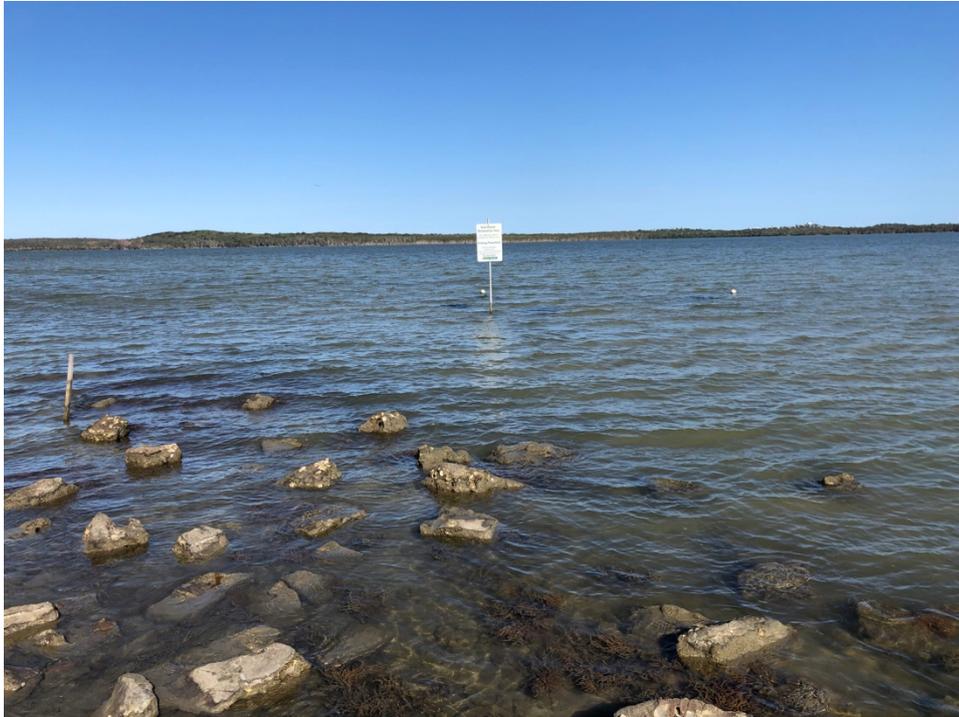
Reef units have not moved substantially from their original position (<0.5m), although due to breakdown of coir mesh observed in October 2019, the oysters contained in the bags have begun to spread to the northwest due to wind driven wave action. There was a high cover of macroalgae observed on bags at this site in October 2019 (Figure 10)

Figure 9 Oyster reefs surrounding sign at Site 16

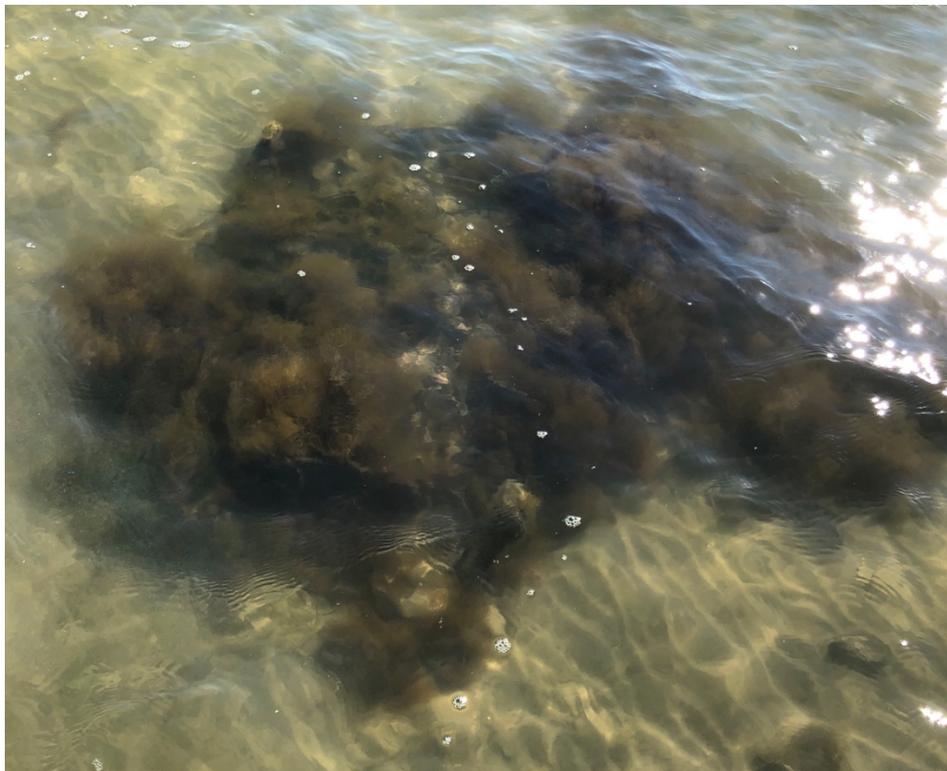
Figure 10 Oyster reef covered with macroalgae at Site 16

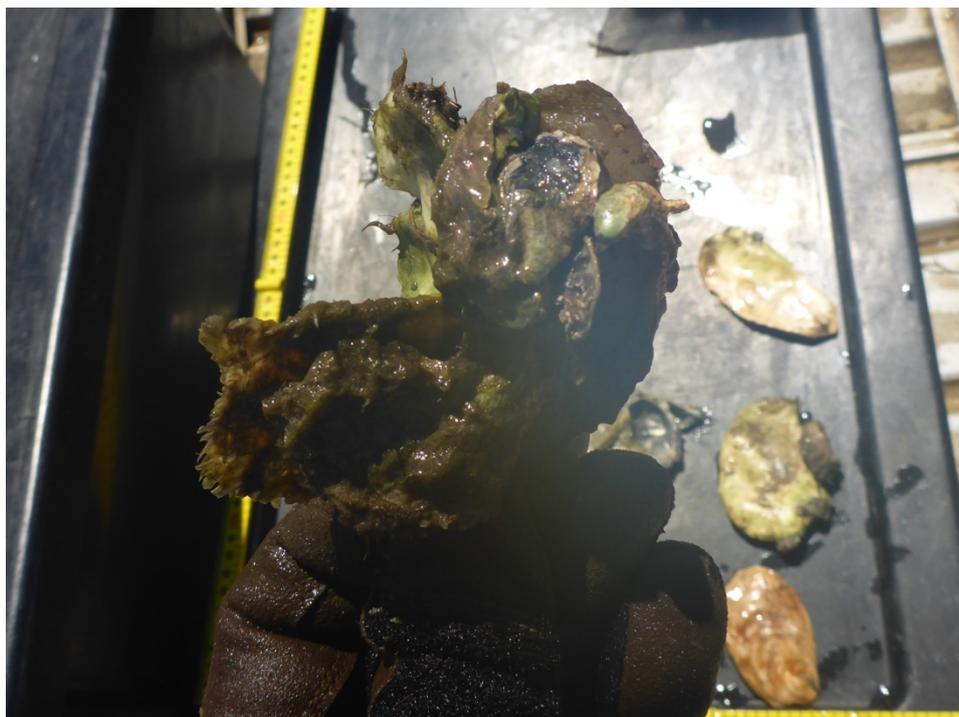
A variety of other sessile invertebrates had recruited to several of the restoration units including other shellfish (hairy mussels, pearl and leaf oysters), sponges and ascidians. These sessile invertebrates are critical for consolidating the oyster shells into clumps (Figure 13 & Figure 14). In October 2019, three sea hares (*Aplysia* sp.) approximately 15 to 20 cm long were also observed grazing on macroalgae growing on the reefs at Site 13 (Figure 15).

Figure 13 Oyster shell consolidated by encrusting sponges and oysters at Site 12

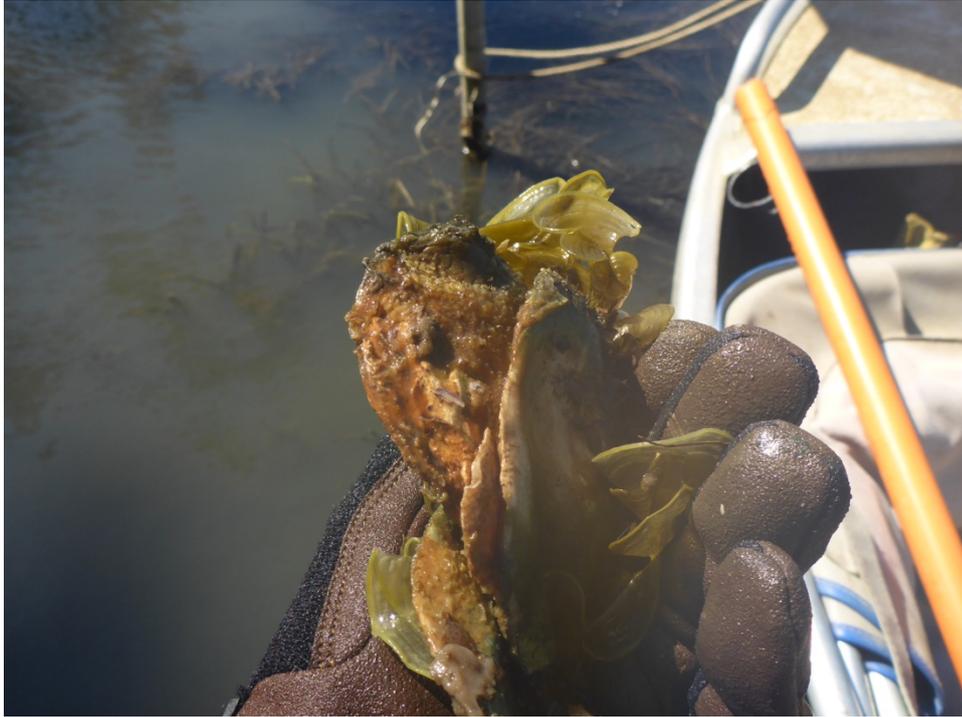
Figure 14 Oyster shell consolidated by encrusting sponges and macroalgae at Site 14

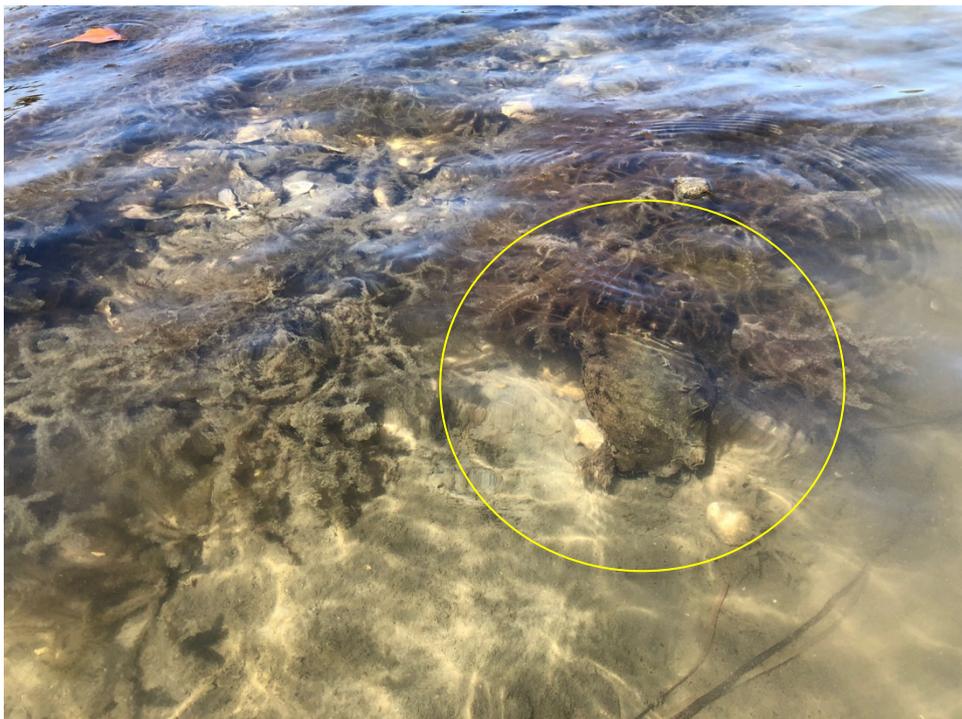
Figure 15 One of three large sea hares (*Aplysia* sp.) consuming algae on oyster reefs at Site 13

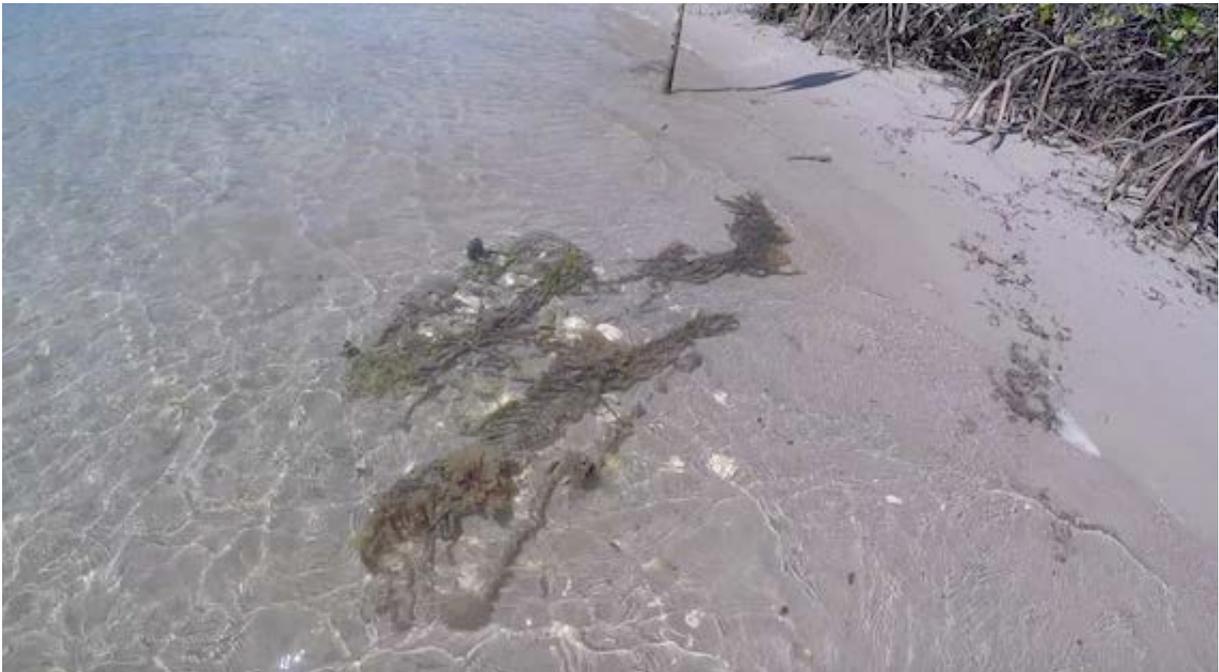
Community use and complaints are monitored through Noosa Council. A community member raised a concern to the restoration steering committee about the state of several reefs along the main Noosa River channel in February 2019. An investigation into the status of the reefs revealed that there had been substantial damage, most likely from repeated boat strikes during the Christmas holiday period (Figure 16), which was supported by anecdotal evidence provided by several local community members during the investigation. Wording on the project signage may have made the restoration areas highly attractive for tourists operating hire boats, who are unfamiliar with local fishing laws and were observed anchoring directly on the reefs in some areas of the main river channel. Despite these areas showing good signs of oyster settlement (Gilby et al. 2018)<sup>4</sup>, it was decided to remove remaining reef structures from 10 restoration sites, due to the high degree of damage to those areas.

Figure 16 Example of boat damage sustained on reef at Site 10 in January 2019 (reef now removed)

While many of the reef areas in the main river channel had good to very good recruitment of oysters, a key learning from the trial is to provide additional communication and education to river users to reduce potential accidental damage. This could be achieved through dedicated signage at boat ramps and accessible information handouts for tourists hiring vessels who may have limited boating experience and be unfamiliar with the objective of the study.

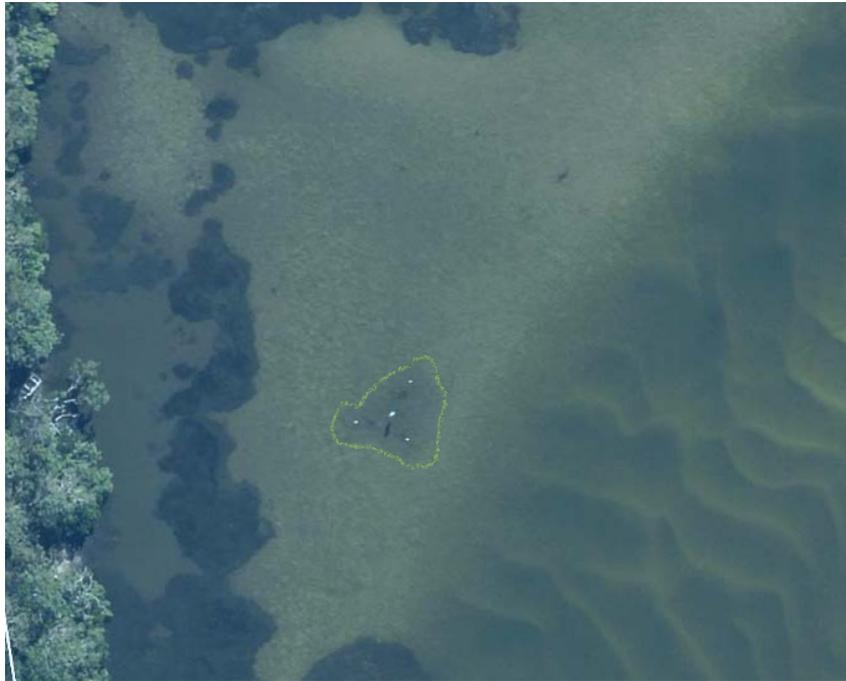
In May 2019, *Halophila ovalis* was observed growing within the RAA at site 13 (as indicated by the darker patch around the restoration structures - Figure 17 & Figure 18), which prior to the installation of restoration structures was an unconsolidated bare sand bank. There was a reduction in the cover of the *Zostera* bed along the shoreline between July 2017 and May 2018 (Figure 19; Table 3 & Table 4). The causal mechanism for this broader change is unclear; however, this area is adjacent to a stormwater outlet and the reduction in seagrass cover is likely due to existing environmental factors, not the placement of restoration structures at site 13 or 14. We completed an additional historical assessment to examine the change in seagrass coverage within 50 metres of the restoration area using imagery sourced from Queensland Globe between 2015 and 2019, and found that the coverage of seagrass adjacent to Site 13 peaked in 2017, then declined by approximately half the area between 2017 and 2018 (Table 3). In 2019 was back to a similar coverage as assessed in 2016 (Table 3). In contrast, coverage of seagrass has increased over time within 50 metres of Site 14 (Table 3).

Figure 17 Extent of sparse *H. ovalis* (outlined in green) growing within the restoration area at Site 13 in 2019
