Noosa Oyster Reef Restoration

Baseline Pre-Deployment Monitoring Report

September 2022

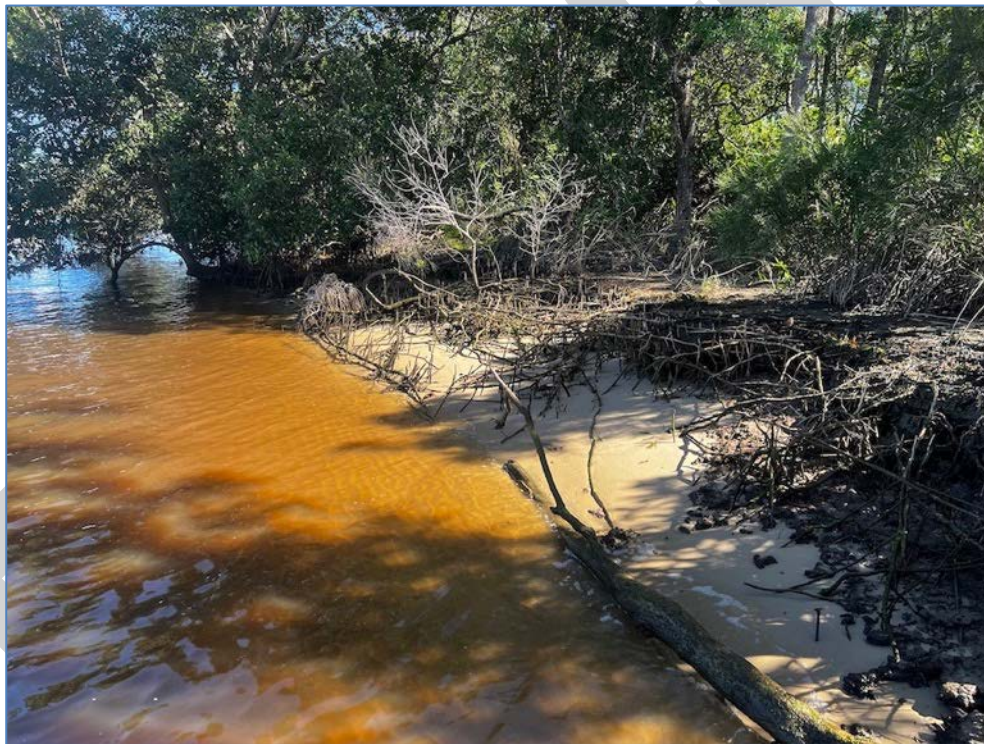
There was evidence of significant shoreline erosion at two of the restoration areas (Tewantin and Goat Island), with steep banks and erosion of sediment, particularly around existing mangrove roots and swamp sheoak (*Casuarina glauca*) where present on the bank (Figure 3.5 to Figure 3.7). The existing erosion at these sites prior to restoration is likely due to scouring from recent flood flows in early 2022, as well as wave driven disturbance from boat wake along the main river channel.

Figure 3.5 Existing shoreline erosion along vegetated banks adjacent to Goat Island Restoration Area

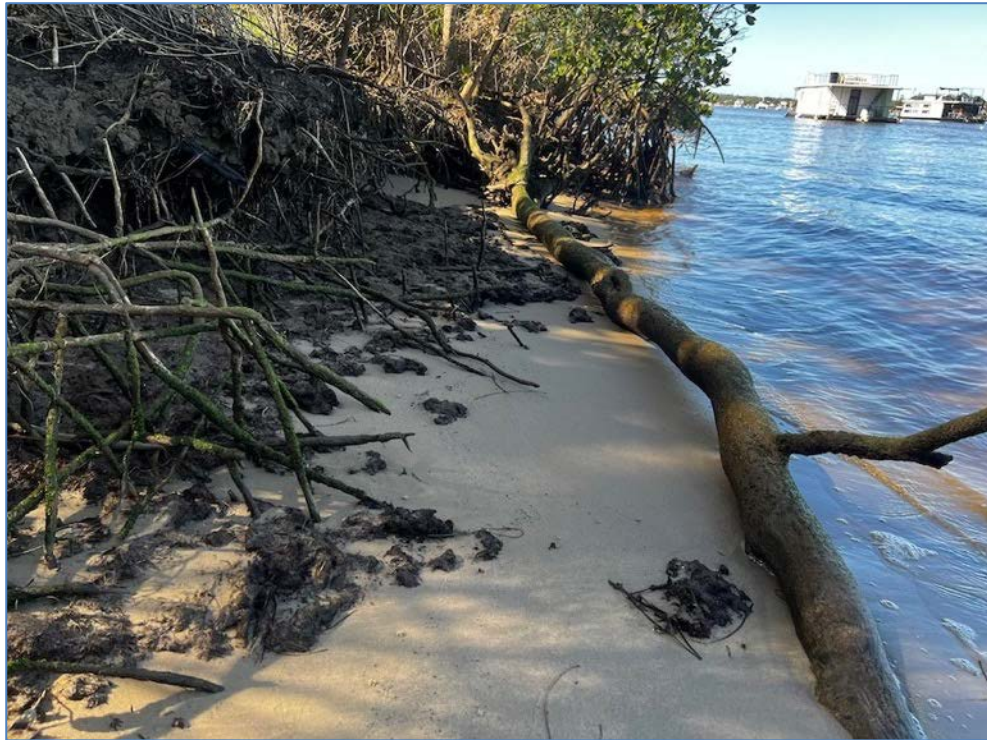
Figure 3.6 Shoreline erosion and undercutting adjacent to Goat Island restoration area

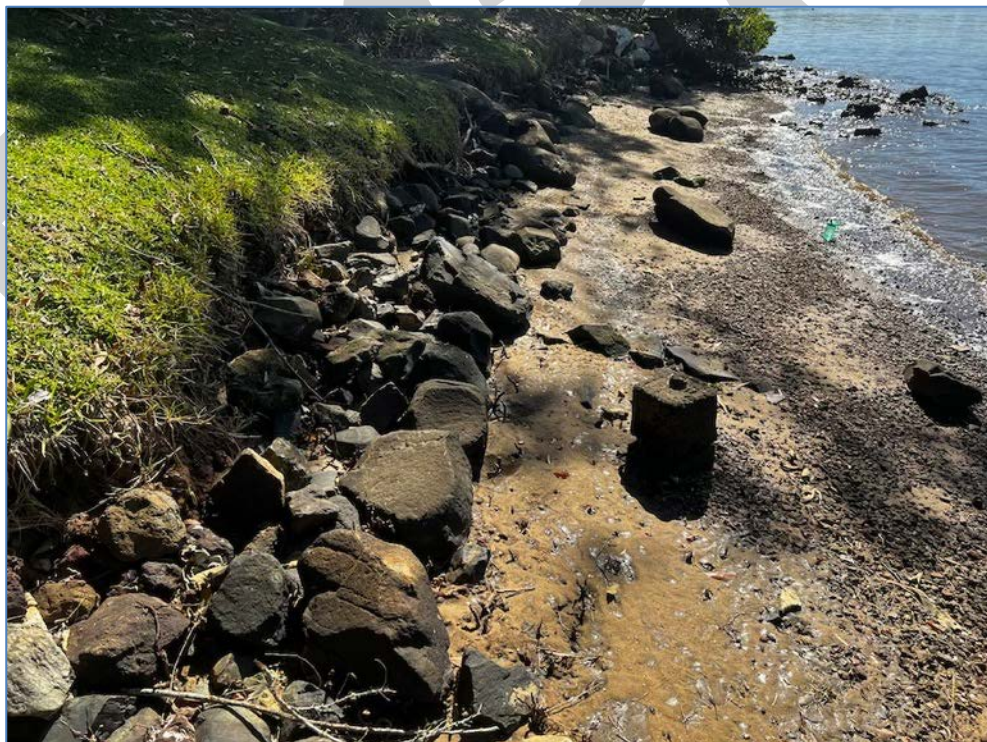
Figure 3.7 Shoreline along the Tewantin restoration area

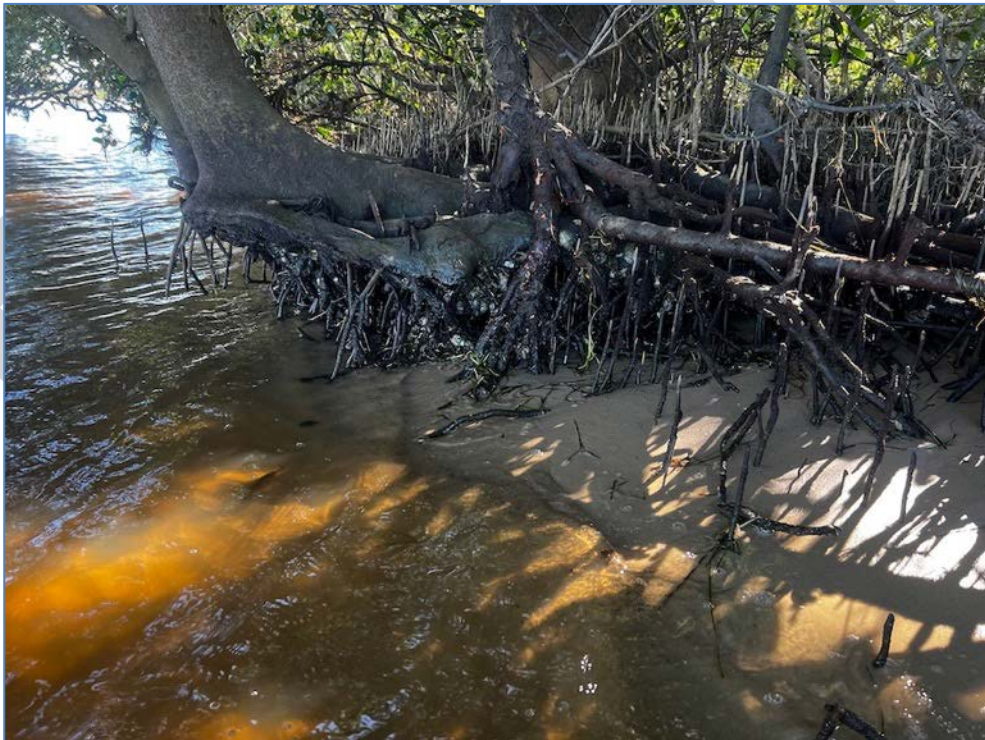
Figure 3.10 Existing low density and patchy distribution of rock oysters growing on mangroves at Goat Island

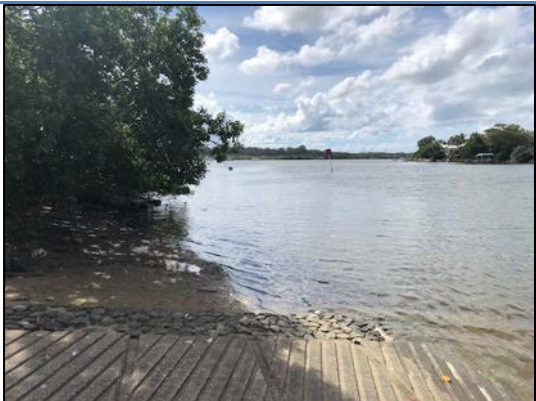
Tewantin	<p>A narrow (<5 m wide) fringing forest dominated by grey and river mangroves, with an upper canopy of coastal hibiscus.</p> <p>Mangroves are in moderate condition, growing on rock and gravel on an erosion prone bank.</p>

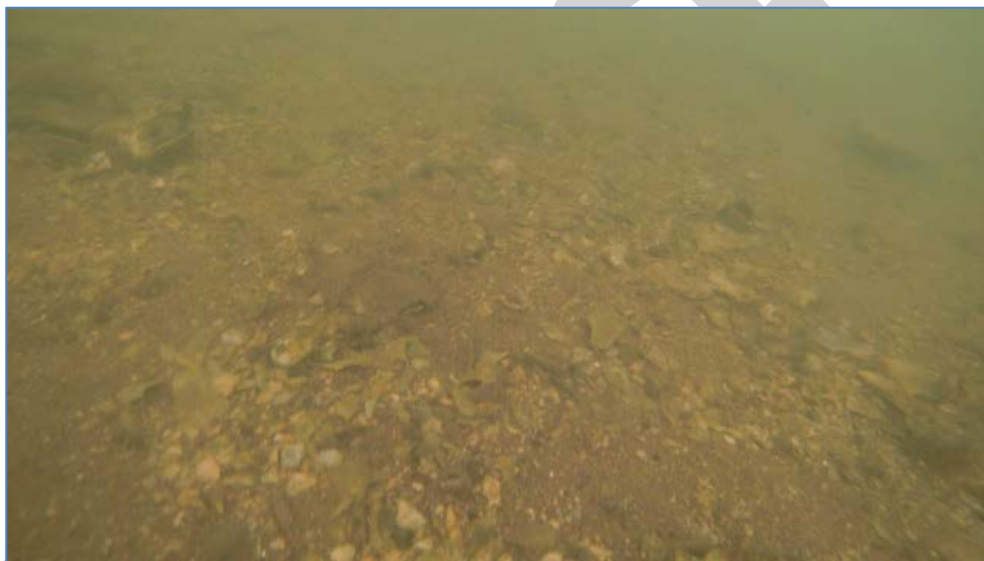
The Tewantin reach has several large areas of gravel with dead oyster shell (Figure 5.3) and rocky rubble (Figure 5.4) that have been buried in places by up to 0.5 m of fine sediment (Figure 5.5), particularly in areas of accretion adjacent to seagrass beds and upstream of the rocky reef surrounding an existing channel marker. In intertidal habitat, oysters aggregated in a narrow band in moderate to low densities on the rock rubble adjacent to the existing mangroves along the bank edge (Figure 5.4). The densest aggregation of oysters were limited to intertidal areas on existing pylons and the rock around jetties. In July 2022, water clarity was extremely poor and we were unable to confirm the presence of subtidal habitats around Tewantin visually. A grappling hook and pole were used to confirm the presence or absence of seagrass and macroalgae at these sites.

Figure 5.3 Gravel with dead oyster shell at Tewantin in 2020
