# Current and Historical Distribution of Seagrass in the Noosa Estuary

**Prepared for: The Nature Conservancy**

**Prepared by Ecological Service Professionals Pty Ltd**

**September 2021**

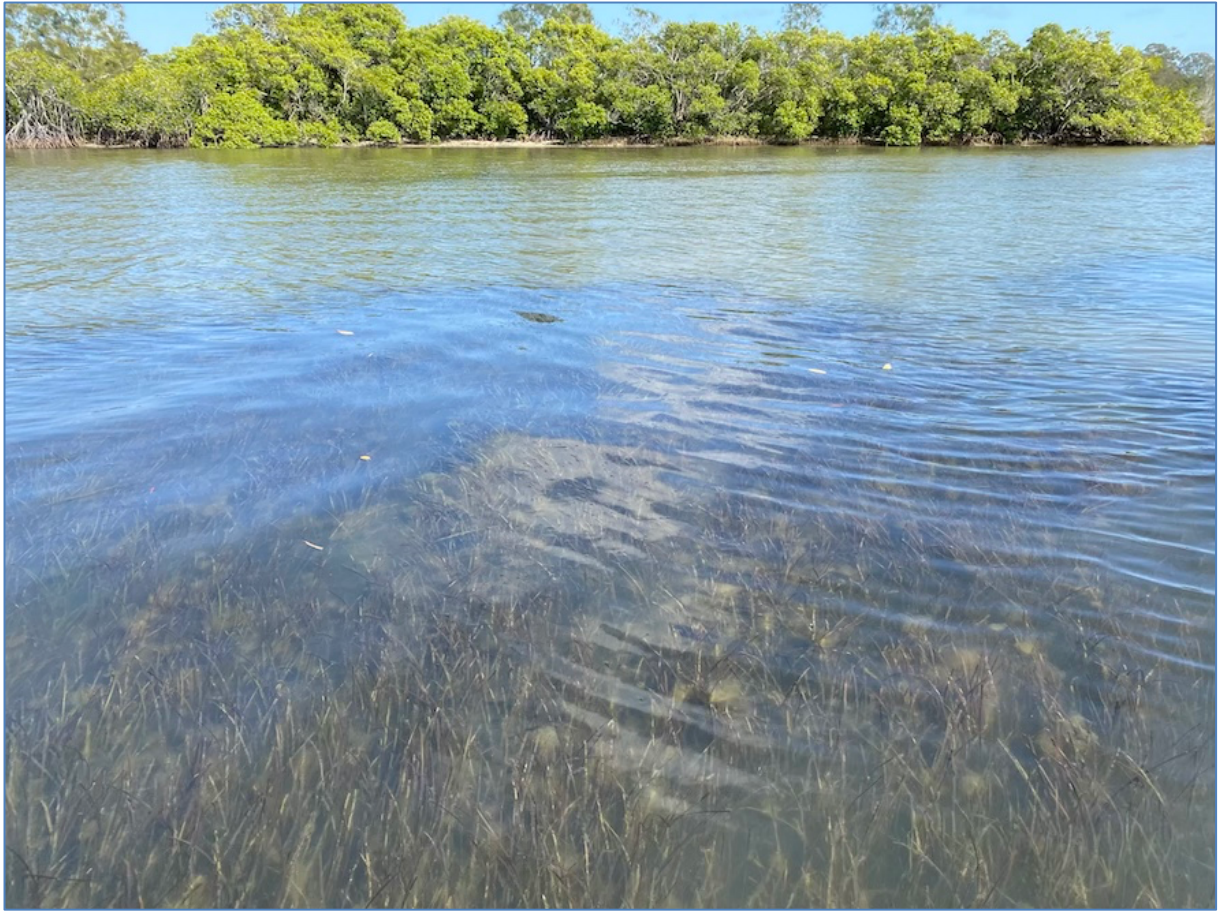
Figure 3.2 Dense *Zostera muelleri* patches along the main river channel at Tewantin

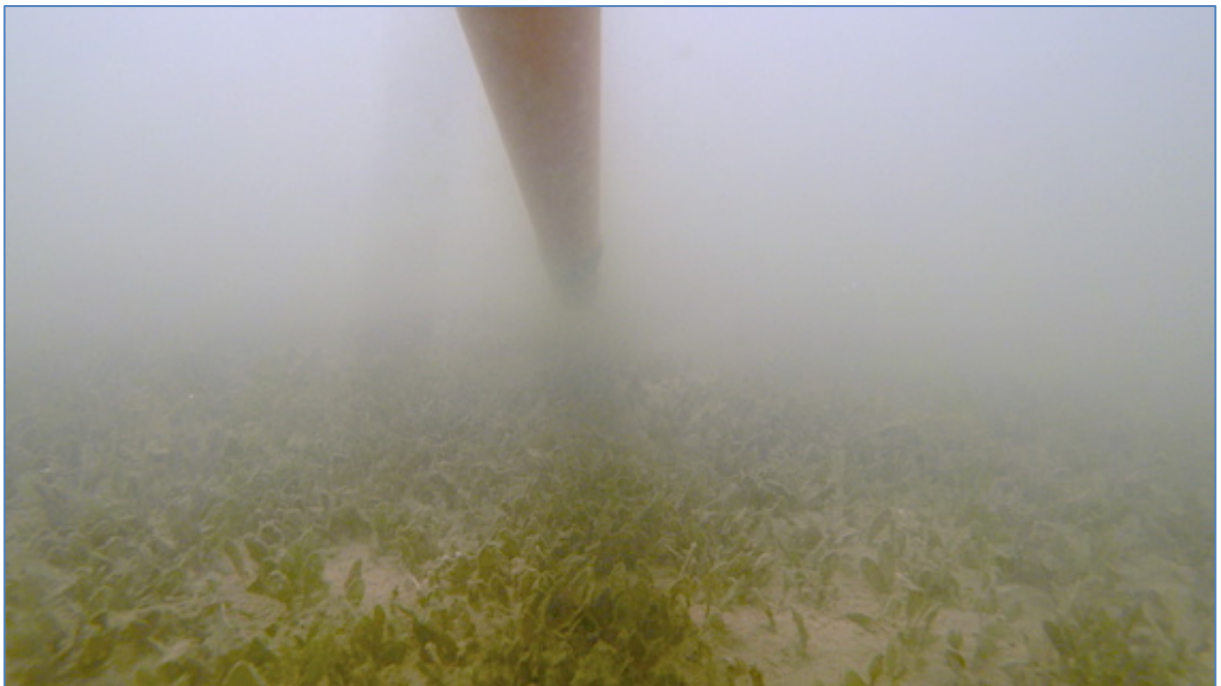
Figure 3.3 Dense *Halophila ovalis* growing in Lake Doonella in November 2020

A total of 56 Ha of seagrass was recorded throughout the estuary in November 2020, with the greatest extent of seagrass occurring in Lake Donnellia and along Weyba Creek (Table 3.1). Seagrass species recorded in the intertidal and shallow subtidal included *Zostera muelleri* subsp. *capricorni* and *Halophila ovalis*. Dense stands of *Z. muelleri* grew along the edge of channels in Weyba Creek (particularly around the mouth of Lake Weyba (Figure 3.1) and Keyser Island), and also along the main river channel at Tewantin (Figure 3.2). Several sparse patches of *H. ovalis* were also recorded on the edges of and between patches of dense *Z. muelleri* (Figure 3.6). Patches of dense *H. ovalis* were recorded in parts of Lake Donnellia (Figure 3.3).

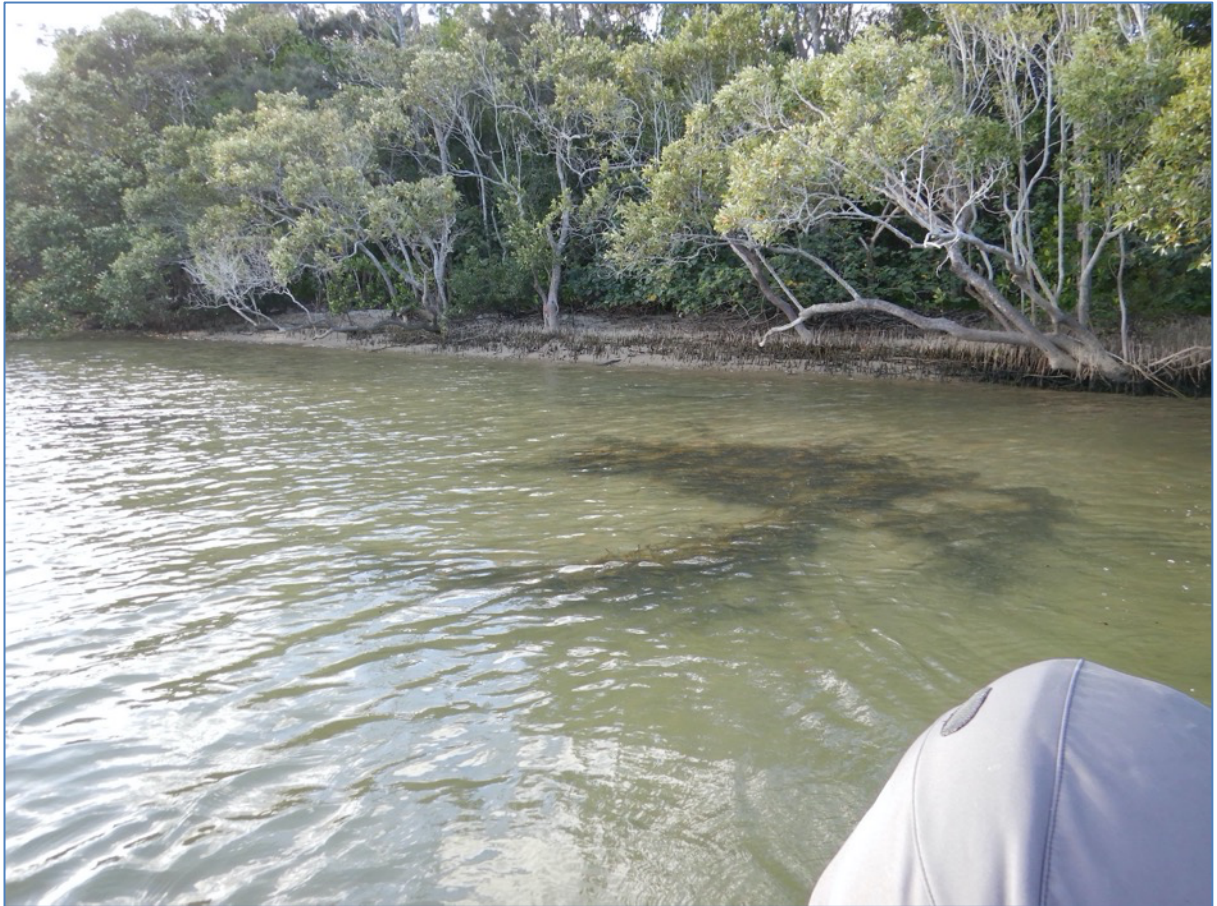
Figure 3.4 Small patch of *Zostera muelleri* growing along the Goat Island in the main Noosa River Channel in November 2020

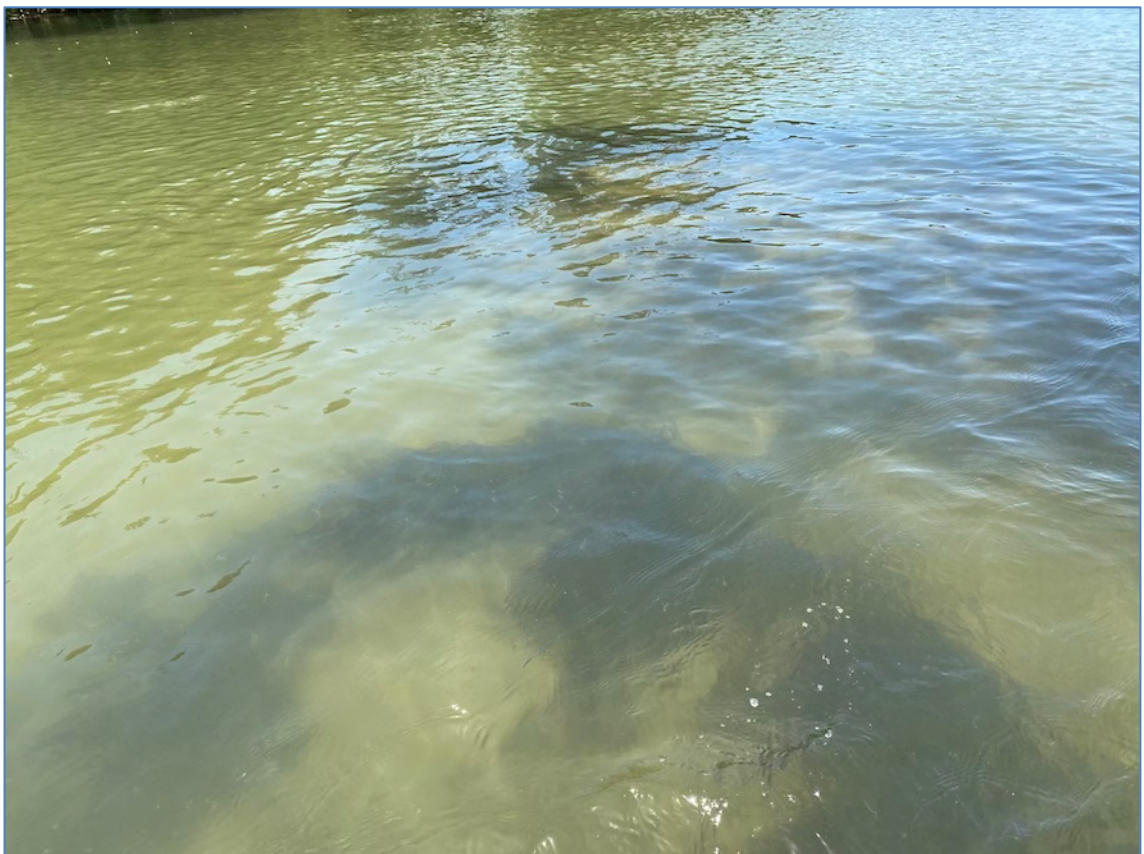
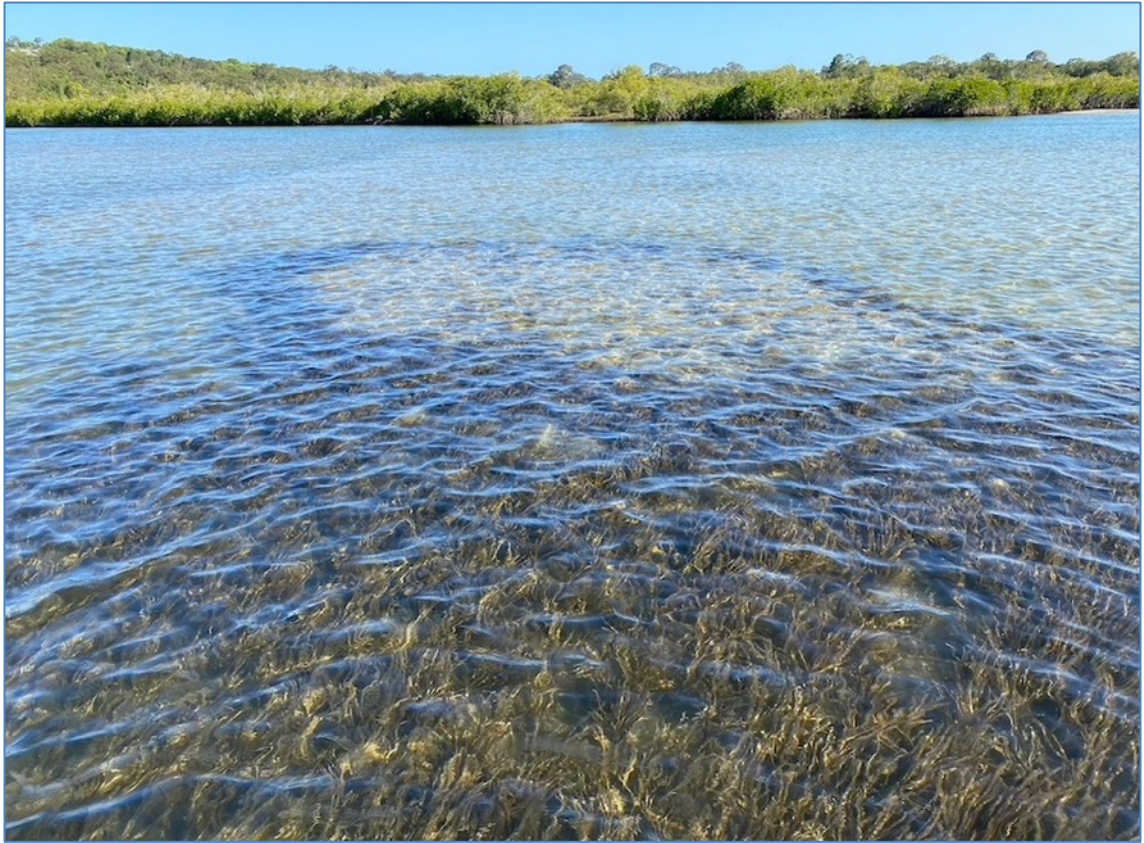
Figure 3.7 Small dense patches of *Z. muelleri* becoming smothered by mobile sand bars in Weyba Creek

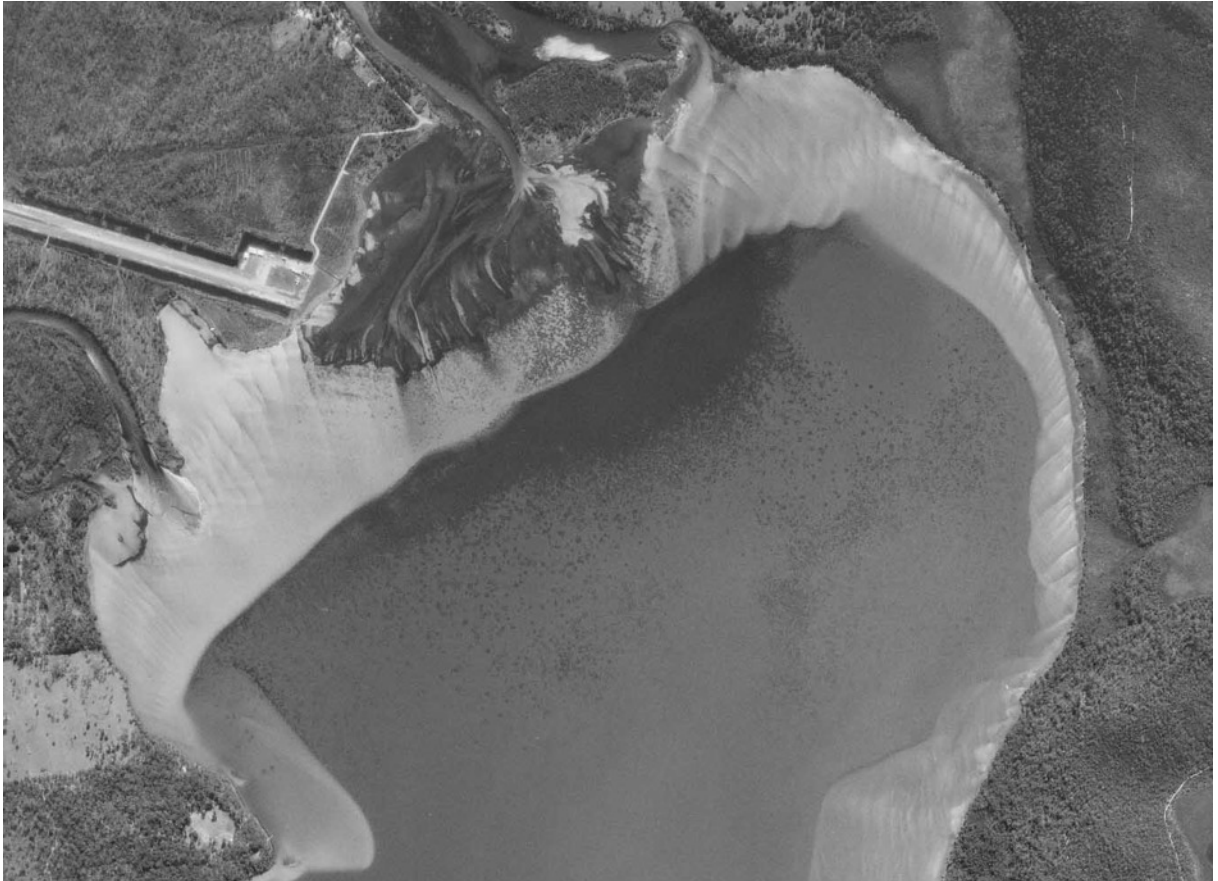
The extent of seagrass in Lake Weyba has changed dramatically over the last 30 years, with large sparse seagrass beds at the mouth of the lake now just a few small patches. While not specifically mapped due to a lack of suitable aerial imagery, there were extensive seagrass beds recorded in Hyland et al 1989, which are visible in available aerial imagery (Figure 4.1). The greatest loss occurred between 1989 and 2006, where large beds of seagrass disappeared from the lake and did not recover. The triggers for the loss of seagrass within the lake remain unknown, but may be related to changes in water quality, interactive or cumulative impacts from flooding (i.e. freshwater flows allowing algae to bloom and outcompete seagrass) or changes in the hydrodynamic regime that prevent seagrass from re-establishing. This initial loss of seagrass in the early 1990s, may have triggered a regime shift to a soft sediment microalgal dominated system where constant resuspension of fine sediment particles directly smother or attenuate light sufficiently to prevent seagrass from restabilising naturally.

Figure 4.1 Extensive seagrass beds (shown as darker patches) at the mouth of Lake Weyba and entrance to Weyba Creek in August 1986 (Source: QLD Government 2021b)

While the exact cause of the decline in seagrass in this reach remains to be determined, this area could be prioritised for possible remediation activities given their remnant nature and endurance and suitability of large areas to support extensive historical seagrass meadows. The restored function, including fisheries productivity gained from re-establishing these extensive seagrass beds could be substantial.

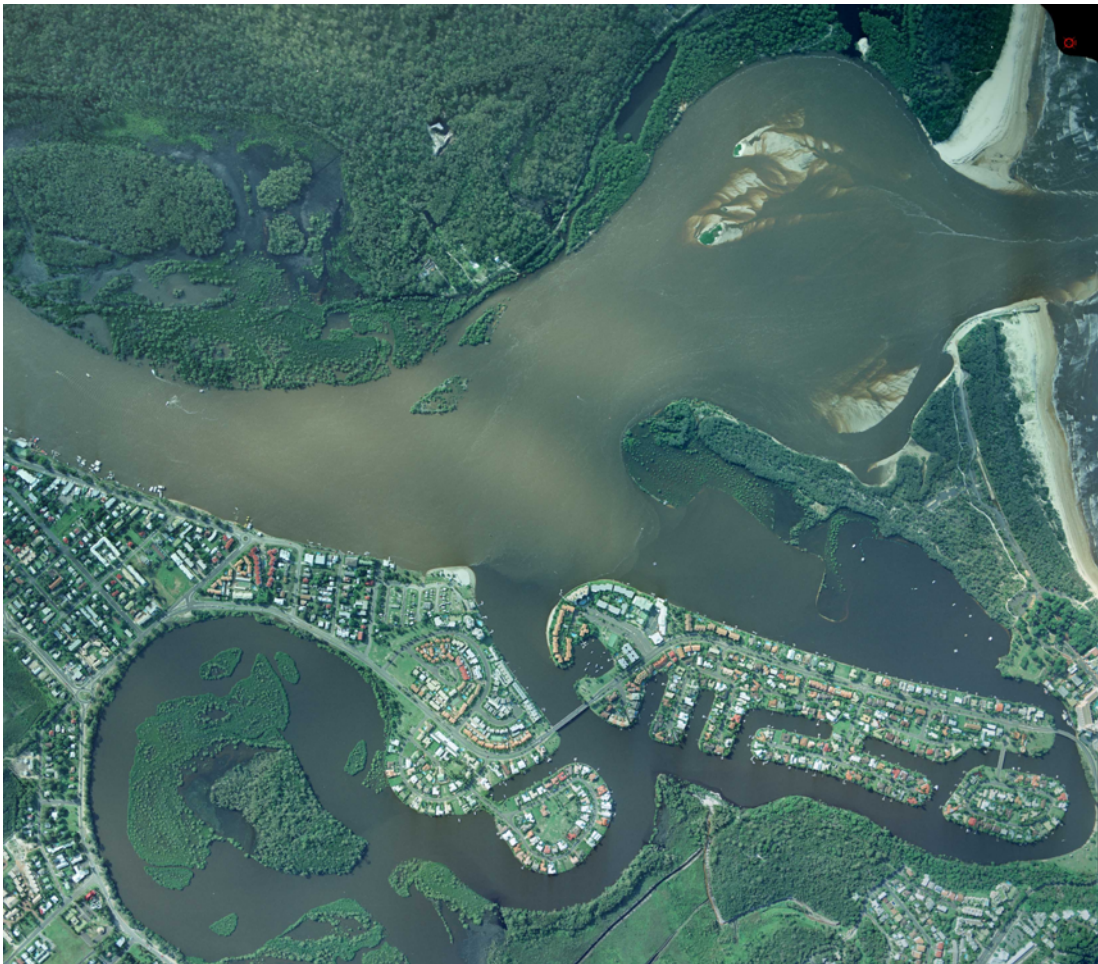
Figure 4.5 Aerial image of the mouth of Noosa River on 24 February 1992 showing the majority of the flood plume bypassing Weyba Creek and Noosa Sound, and extending out into Laguna Bay (Source QLD Government 2021a)

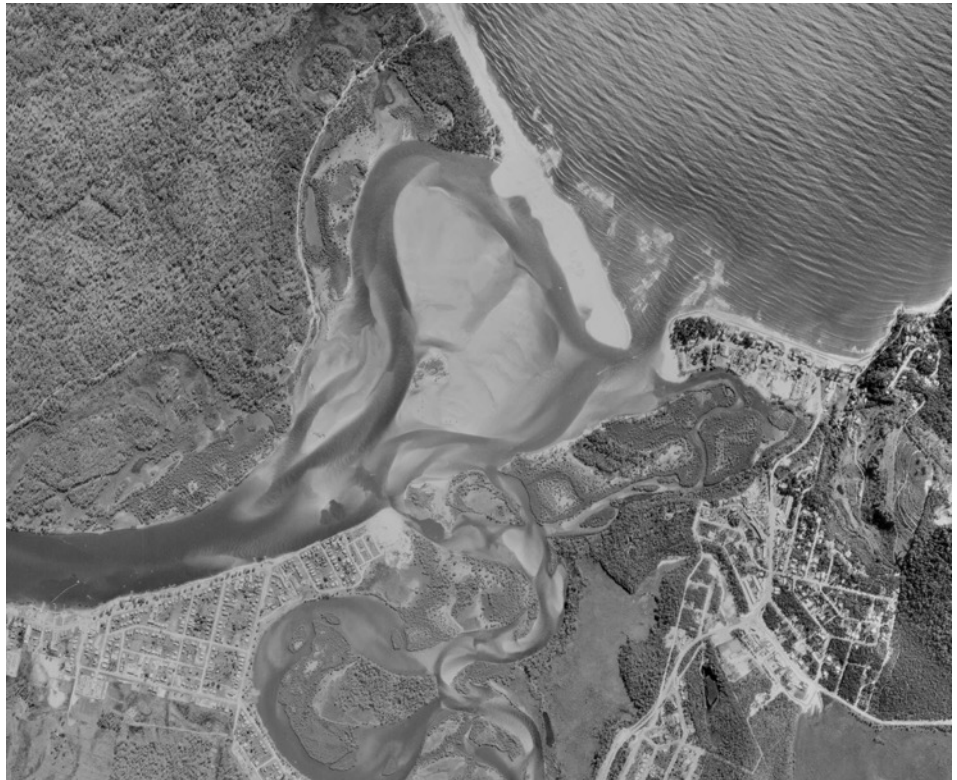
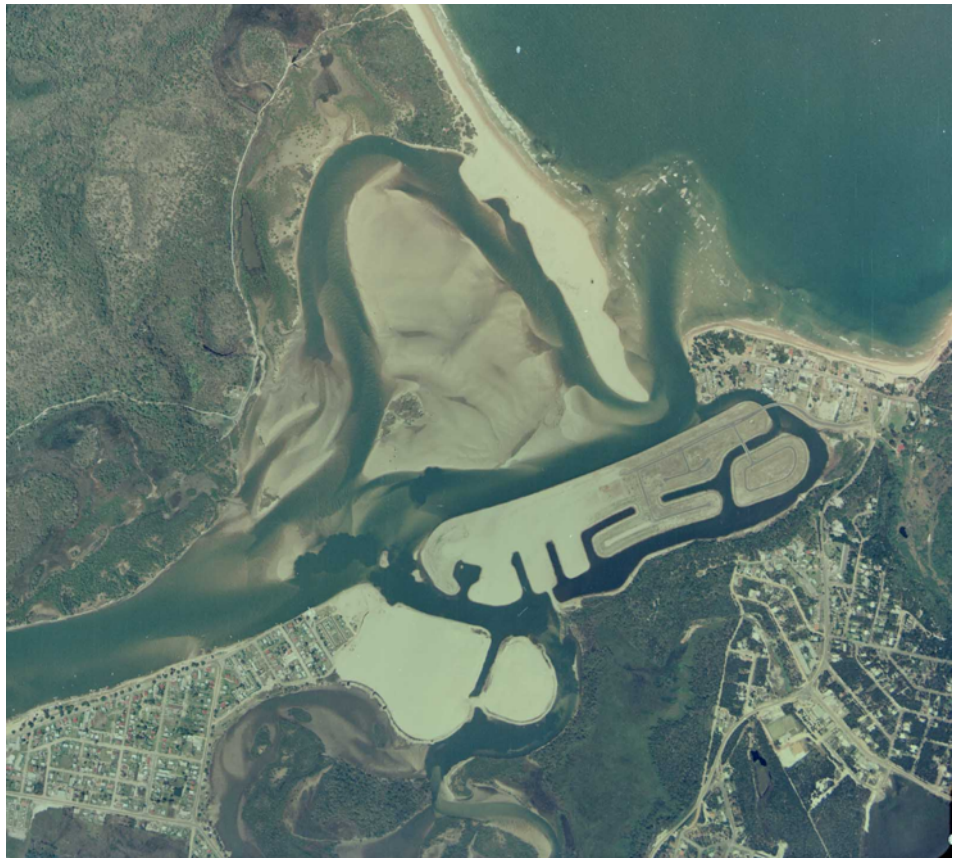
Figure 5.1 Aerial imagery from (a) June 1972 and (b) November 1974, showing the change in estuarine habitat due to urban development at the mouth of the Noosa Estuary (Source QLD Government 2021a)
