Noosa River Oyster Restoration

Noosa River Oyster Restoration Project

PHASE 1 - AS CONSTRUCTED DRAWINGS

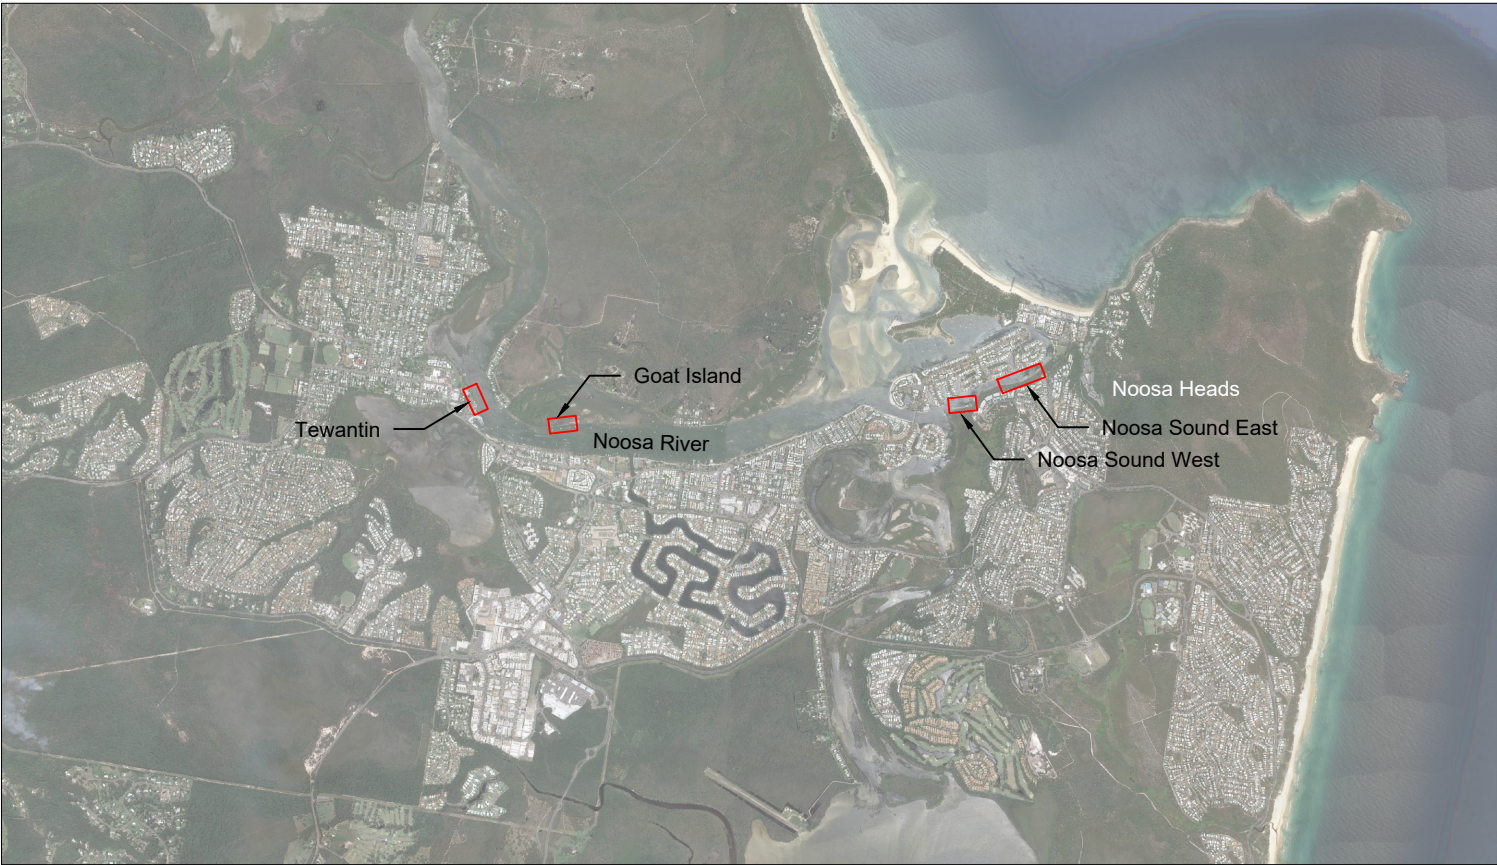
Tewantin As-Constructed

Point	Easting	Northing
A	504143.8	7080822.5
30m distance from boat		
B	504157.2	7080824.7
C	504167.3	7080839.2
Extent of rocky rubble		
D	504153.5	7080881.8
E	504127.4	7080891.6
F	504129.3	7080902.0
Extent of rocky rubble		
G	504117.6	7080922.3
H	504109.5	7080919.9
10m distance from seagrass		
I	504096.7	7080913.6
MHWS/Vegetation

SUBMARINE CABLE LOCATION
Surveyed by Accurate Service Locators

- Navigation Aid locations provided by M&J Marine.
 - Submarine cable located on-site by Accurate Service Locators using ground penetrating radar to be >5m north of setout point F and point H.

- Reef patches T1 & T2 have a composite substrate of rock and cured oyster shell.
 - Total area of rock placed 439m²
 - Total shoreline length of restoration area 104m.

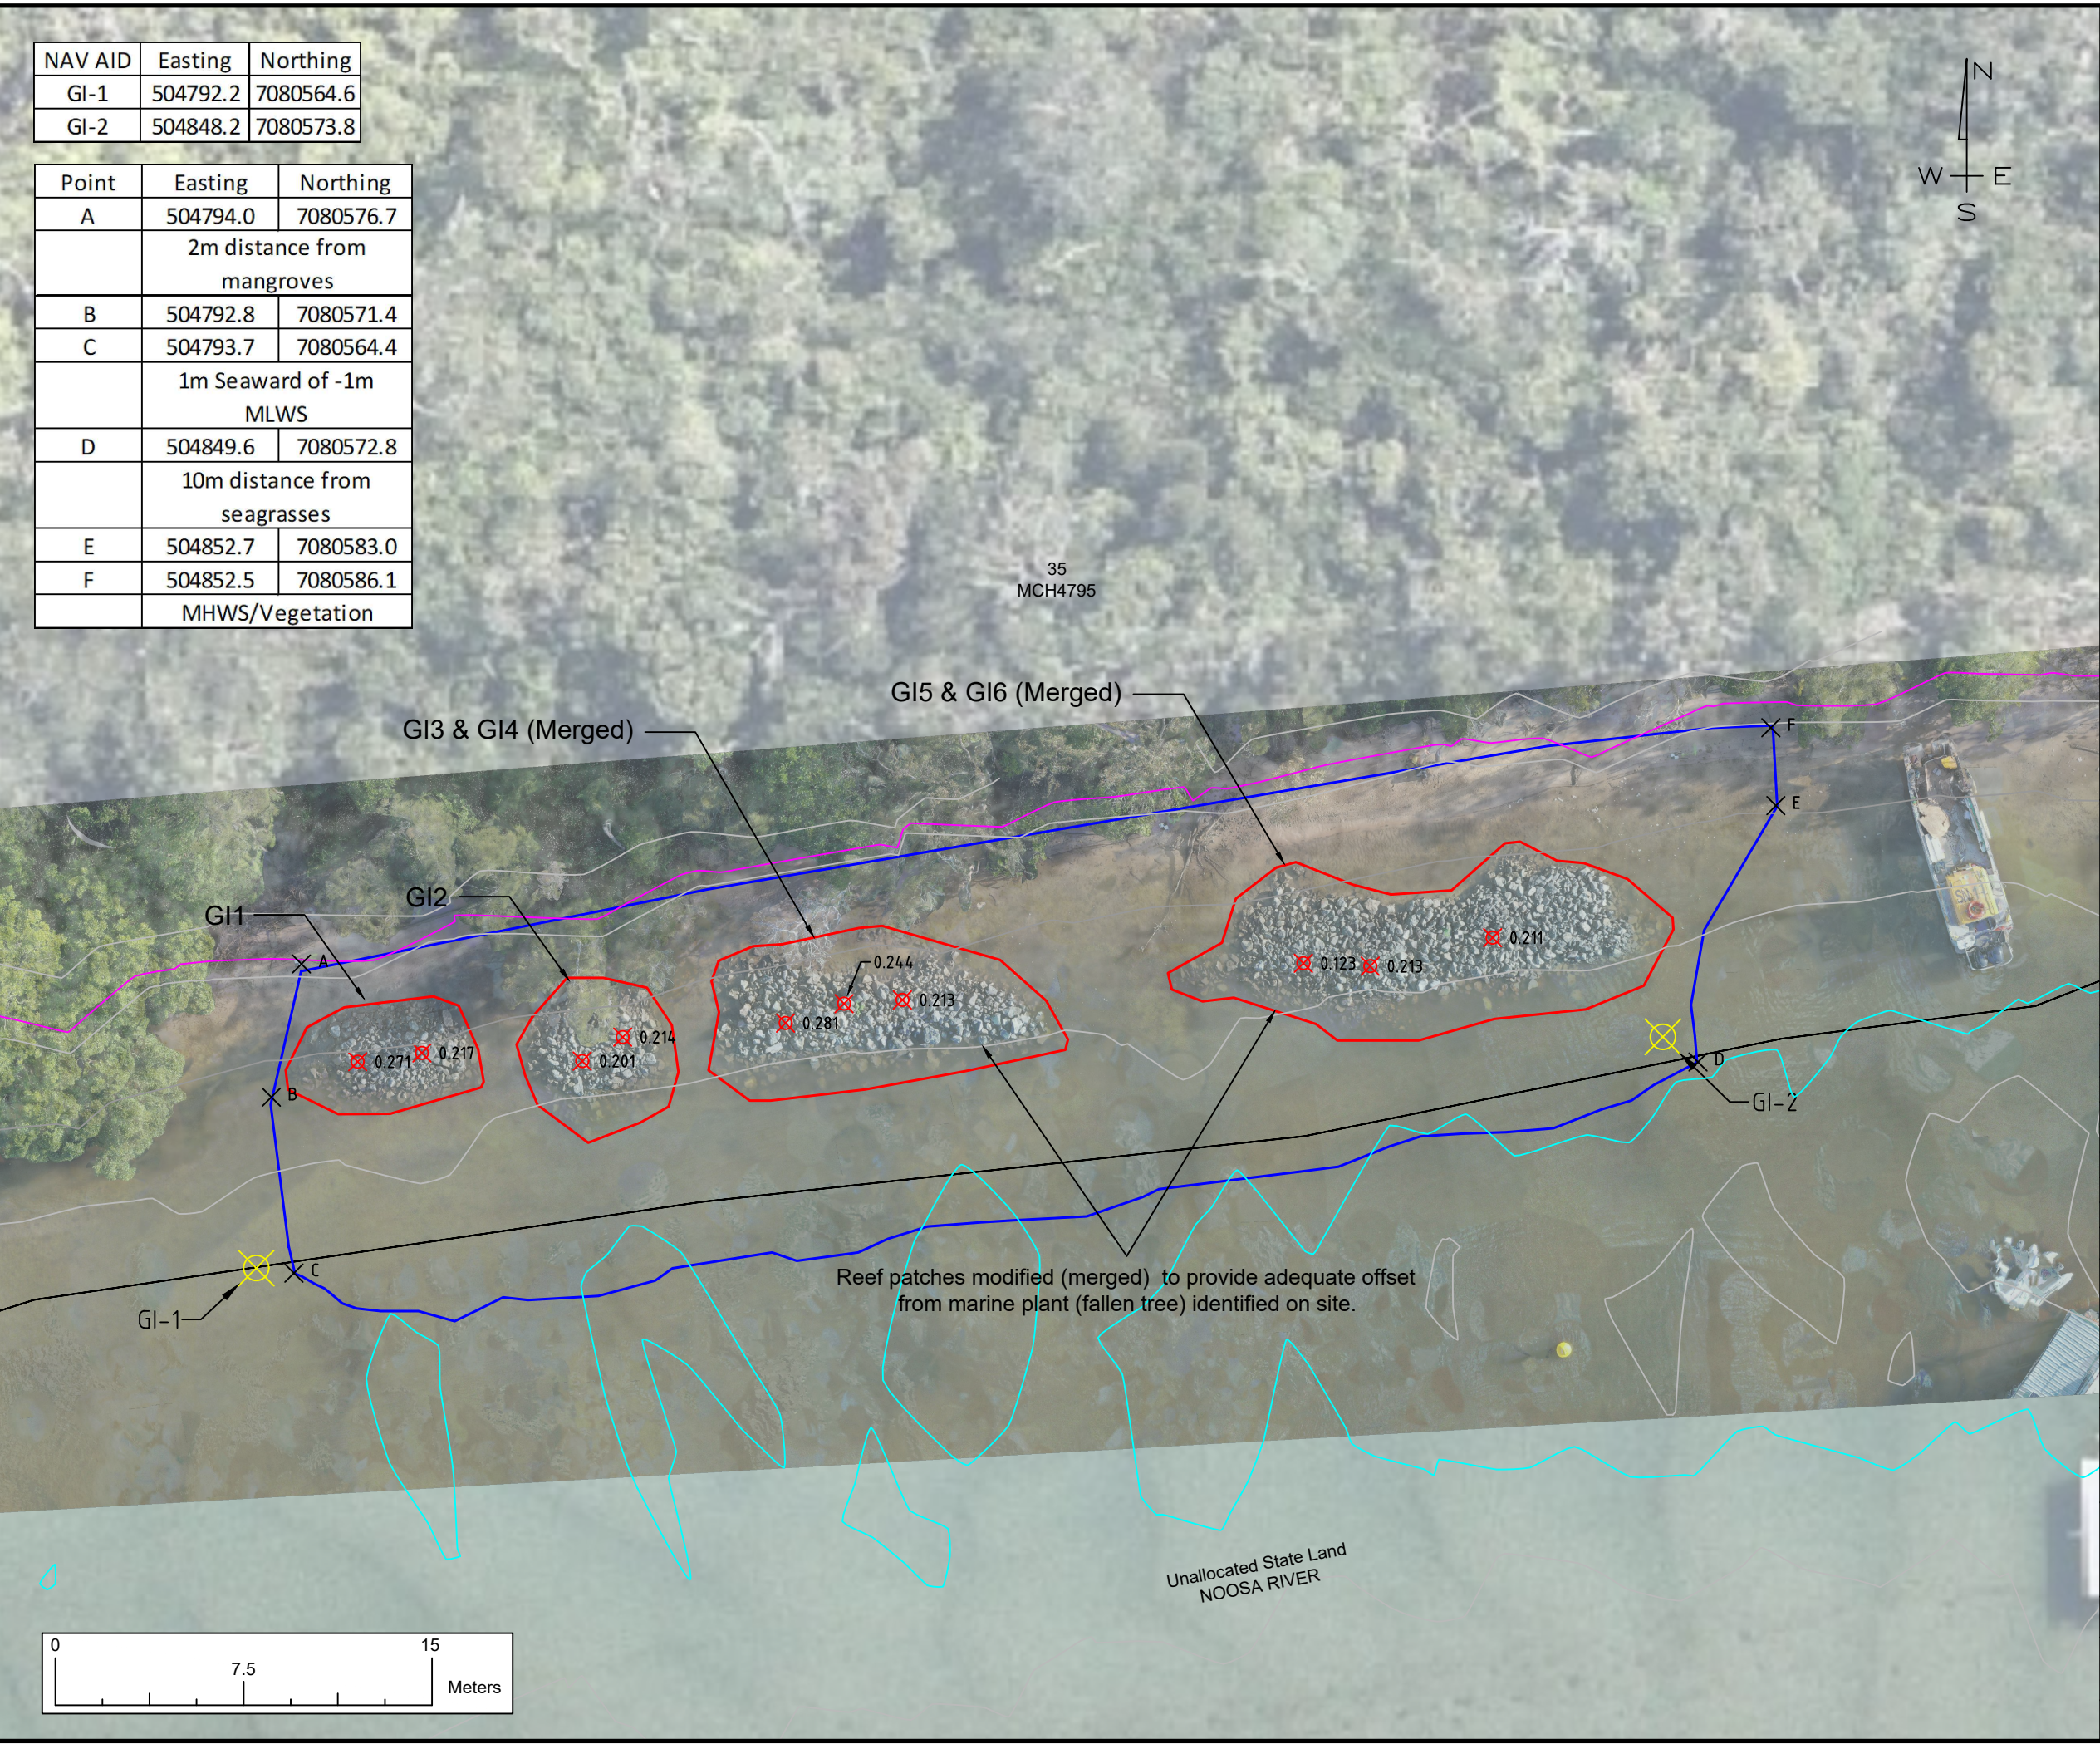
Noosa Sound West As-Constructed

Point	Easting	Northing
A	508169.1	7080729.4
B	508168.3	7080733.3
1m Seaward of -1m		
C	508256.1	7080757.3
D	508260.5	7080744.5
MHWS/Vegetation

- Navigation Aid locations provided by M&J Marine.
- Restoration Footprint.
 - Shoreline extent defined by setout points from approved restoration plans. Setout points have been transformed from GDA94 to GDA2020. Seaward extent near NSW4&5 adjusted to reflect additional survey data collected prior to commencement of works.

- Total area of rock placed 600m²
 - Total shoreline length of restoration area 92m.
