Noosa’s Huon Mundy Reefs – performance update

Summer 2023

ESP undertook baseline site assessments prior to the laying of the reef patches. In March 2023, ESP undertook the second monitoring event. The results of that monitoring are reported in: *Noosa’s Huon Mundy Reefs – performance update – Winter 2023*. This document summarises the key findings from September 2023 monitoring event, 12 months after reef construction.

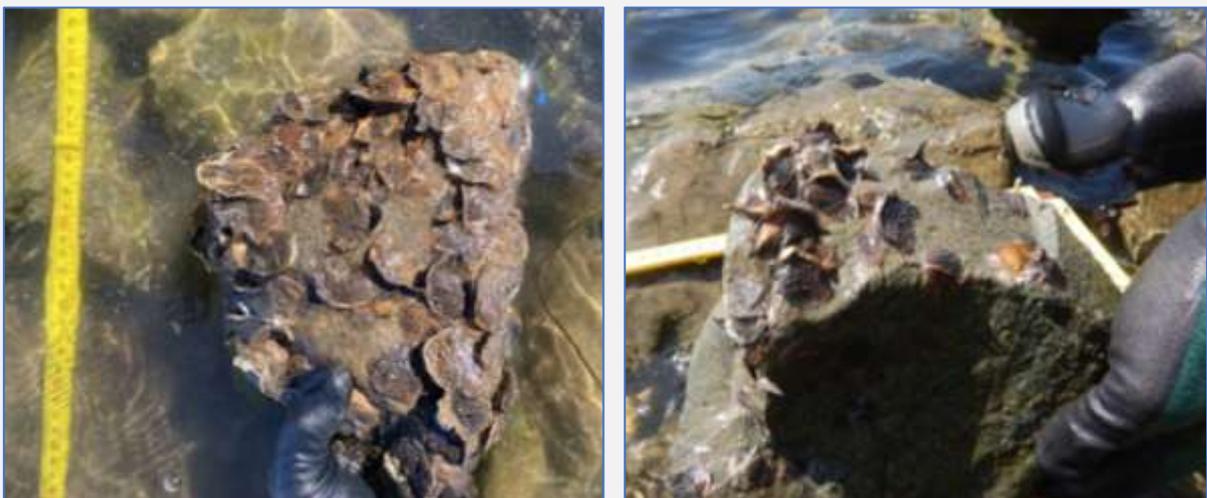
Oysters continue to grow primarily on the underside of the rocks (Figures 2,3) and, in some places, up the sides of the rocks.

Figures 2 and 3: Oyster density at Goat Island and at Noosa Sound East (Photos by S.Walker/ESP)

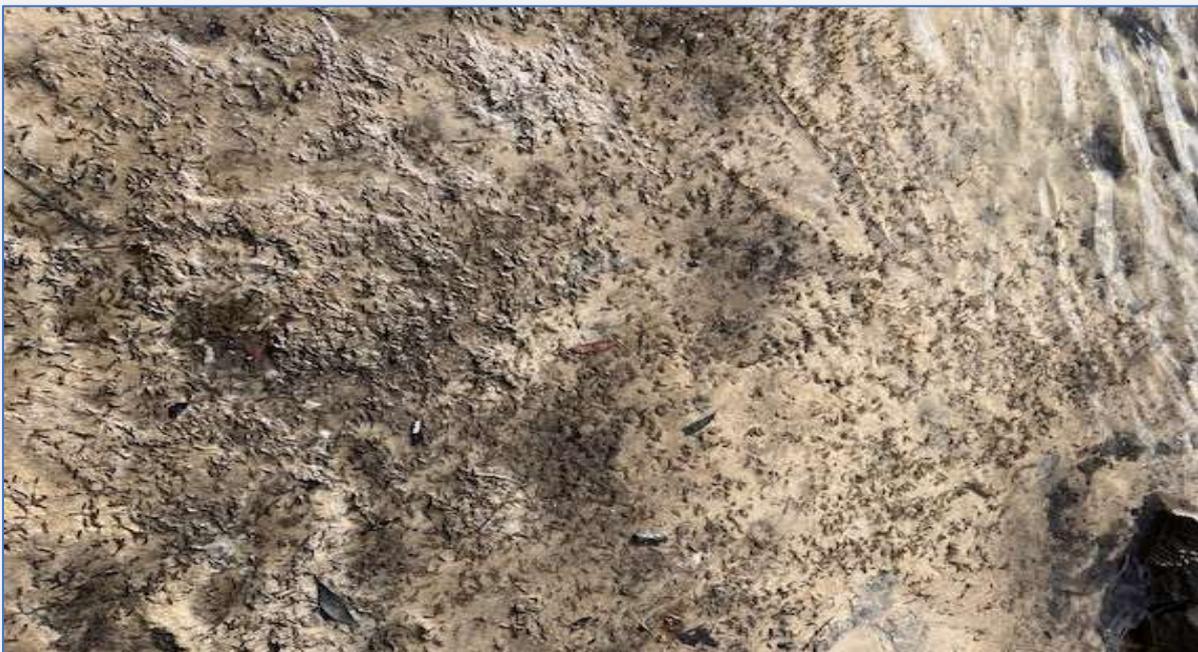
The greatest change in benthic habitat between March and September 2023, was the substantial increase in the extent of seagrass growing around the reef patches. This was particularly prevalent at the Noosa Sound East and Noosa Sound West restoration areas, where seagrass covered 409.3 m² and 554.5 m² of sandy riverbed respectively (Figures 4, 5).

Figure 4: Seagrass (*Halophila ovalis*) growing between reef patches at Noosa Sound East (as seen at low tide), September 2023 (Photo by S.Walker/ESP)

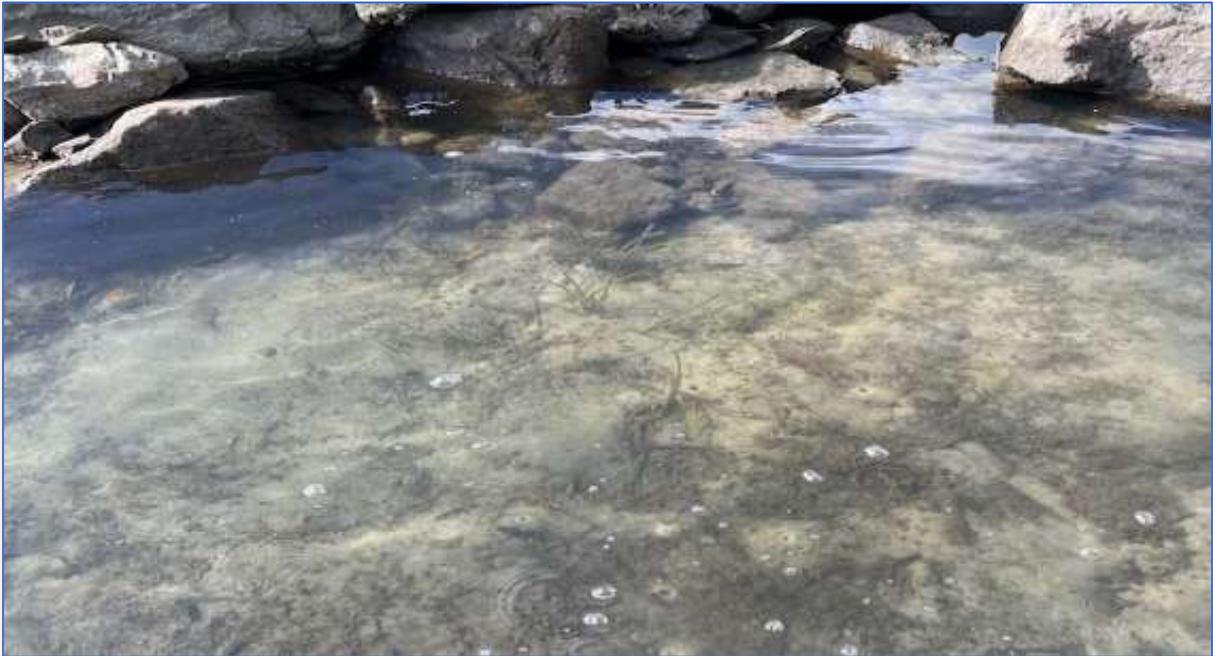
Figure 5: Seagrass (*Halophila ovalis*) growing between reef patches at Noosa Sound West (as seen at mid tide), September 2023 (Photo by S.Walker/ESP)

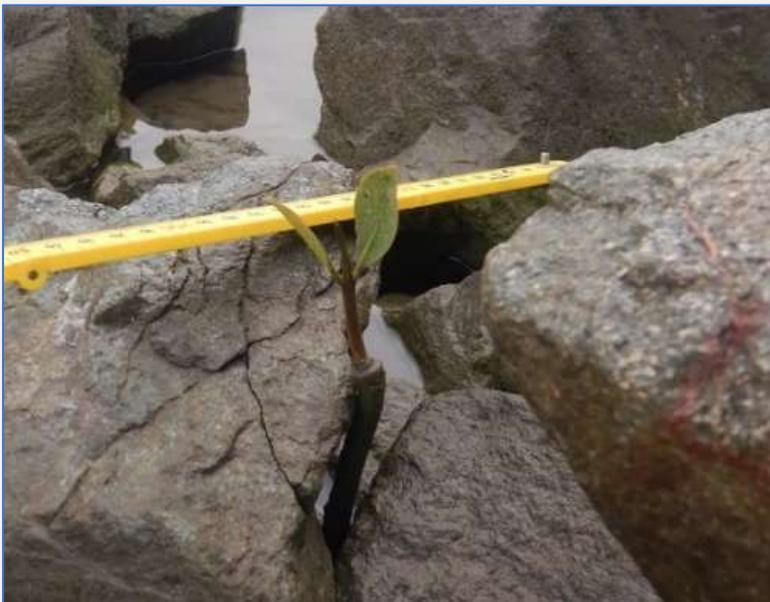
Several mangrove propagules (predominantly red mangroves *Rhizophora stylosa*) however have established on reef patches at each of these restoration site (Figure 6). There was also recruitment of mangrove propagules onto sand banks along the inner section of the reefs at Goat Island.

Figure 6: Mangrove propagule establishing on a reef patch at Goat Island (Photo by S.Walker/ESP)

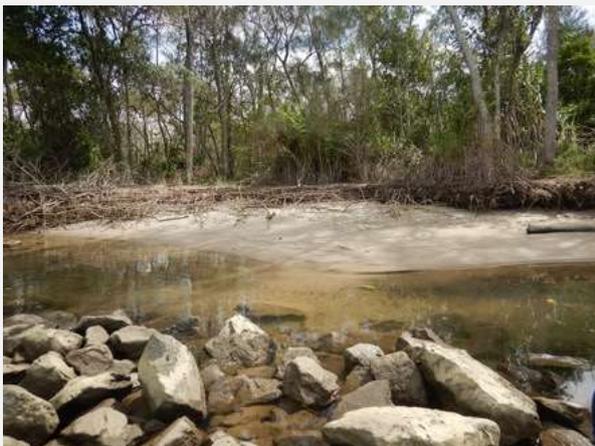
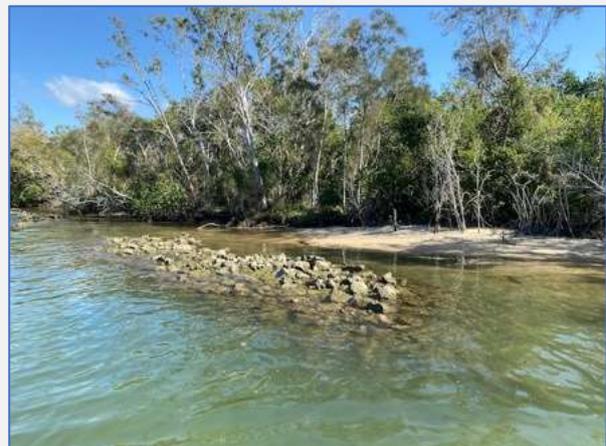
In September 2023, sand had continued to accumulate on the shoreward side of reef patches at Goat Island restoration area (Figures 7,8). However, between several reef patches, and along the shore outside of the restoration area, there was continued undercutting of the bank vegetation where wave energy was not attenuated (reduced) by the reef patches.

Figures 7 and 8: Sand accumulation shoreward of reef patches at the Goat Island restoration area (Photo by S.Walker/ESP)

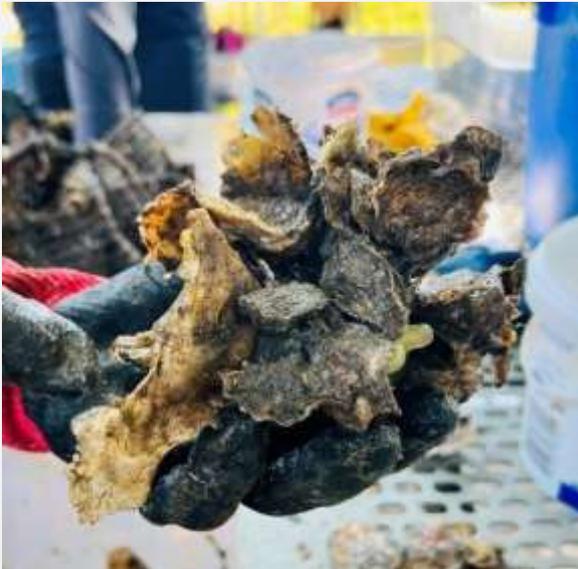
Figure 10: Aggregation of rock oysters extracted from an oyster garden, October 2023 (Photo by J Bloomfield)

The first oyster gardening cycle was concluded in October 2023 with all oyster gardens retrieved from registered gardeners and brought to the *Oyster Gardening Audit Workshop* at Tewantin. NICA volunteers and contractors, guided by TNC opened, inspected, weighed, and processed all gardens. Fully grown adult oysters from the gardens were subsequently deployed onto the *Huon Mundy reefs* to help kick start ecosystem recovery, whilst the remaining sub-adult oysters were retained in baskets, under the care of NICA, to grow out further.
