Noosa Oyster Reef Restoration

Baseline Pre-Deployment Monitoring Report

September 2022

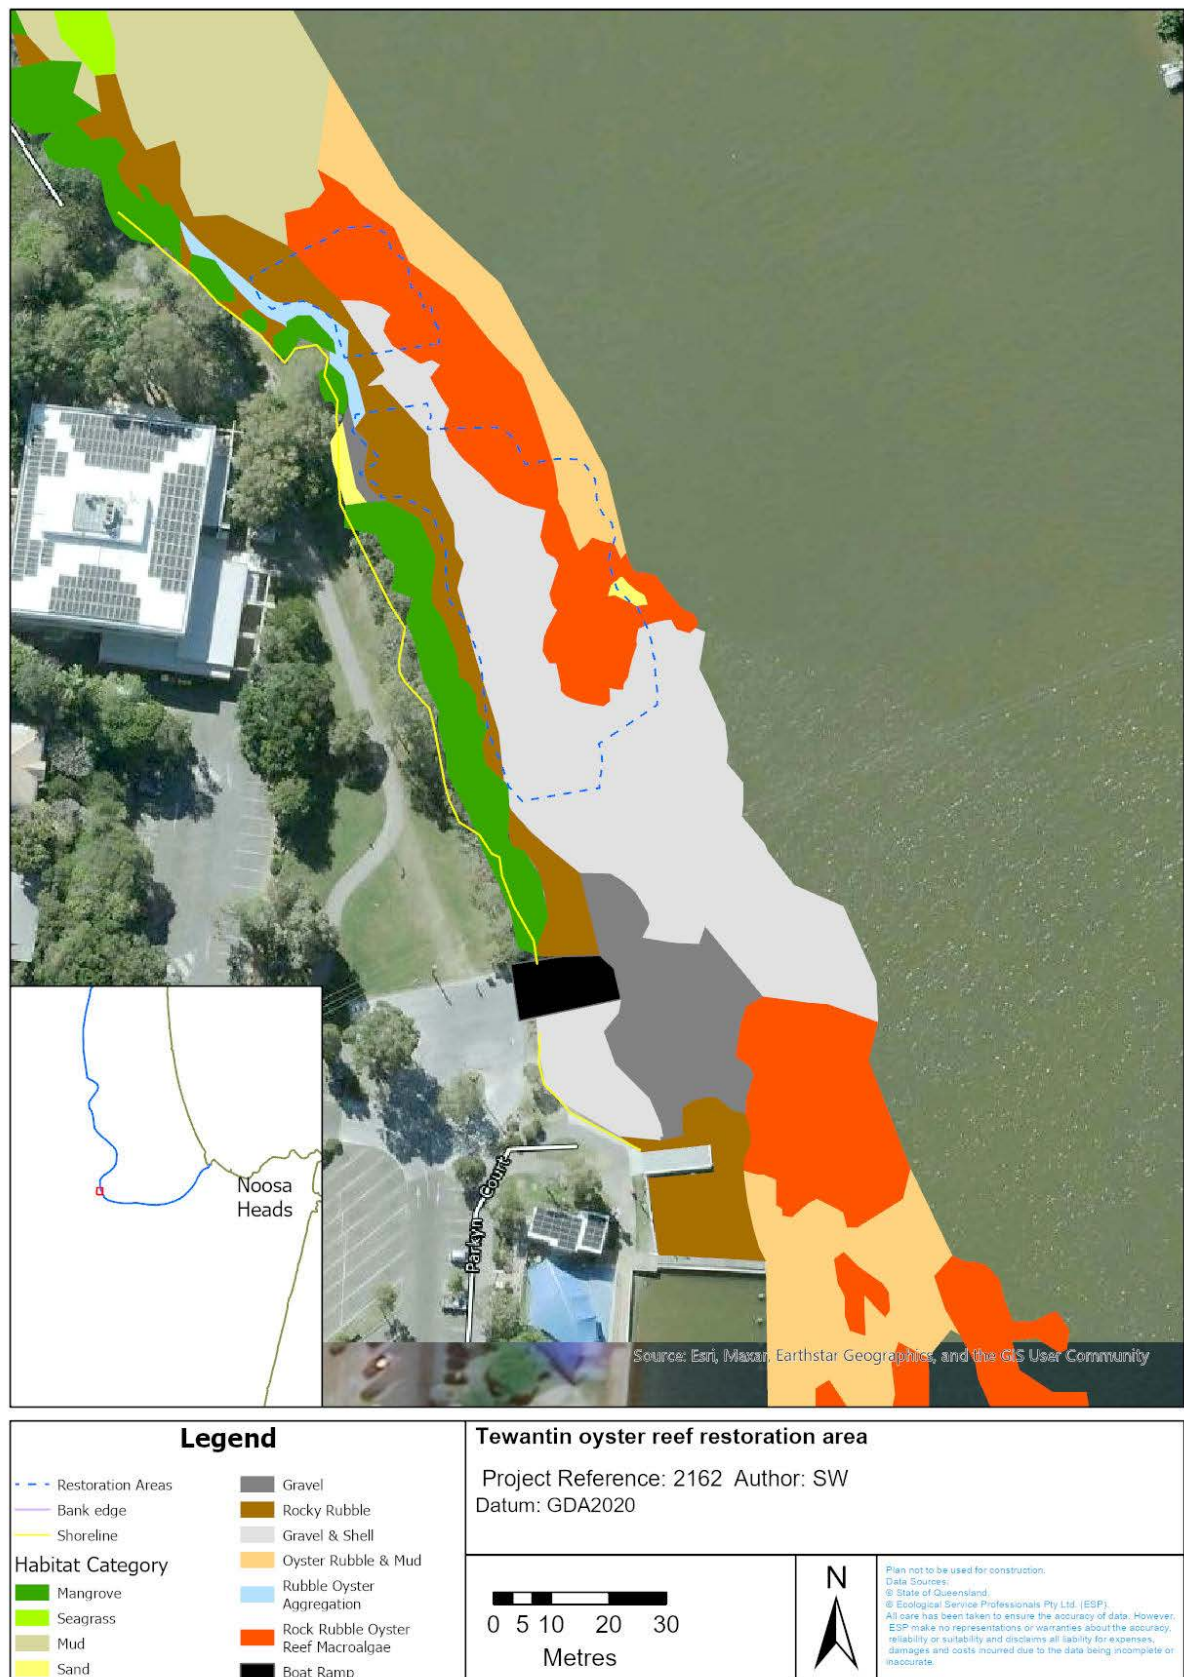
Figure 3.1 Habitat map and shoreline at Tewantin restoration area

As previously assessed (ESP 2021), the dominant habitat type in the restoration areas in 2022 prior to reef deployment was bare sand (Figure 3.1 to Figure 3.4). There were some small patches of seagrass (<30 m²) recorded adjacent to the restoration areas at Tewantin and Goat Island in 2020 that were not present in July 2022, due most likely to habitat contraction in response to flooding and prolonged periods of high turbidity (and therefore low light penetration necessary for seagrass growth) in 2022. The closest patch of seagrass to the Goat Island restoration area was recorded approximately 200 m upstream, and the closest patch of seagrass adjacent to the Tewantin restoration areas was 43 m upstream.

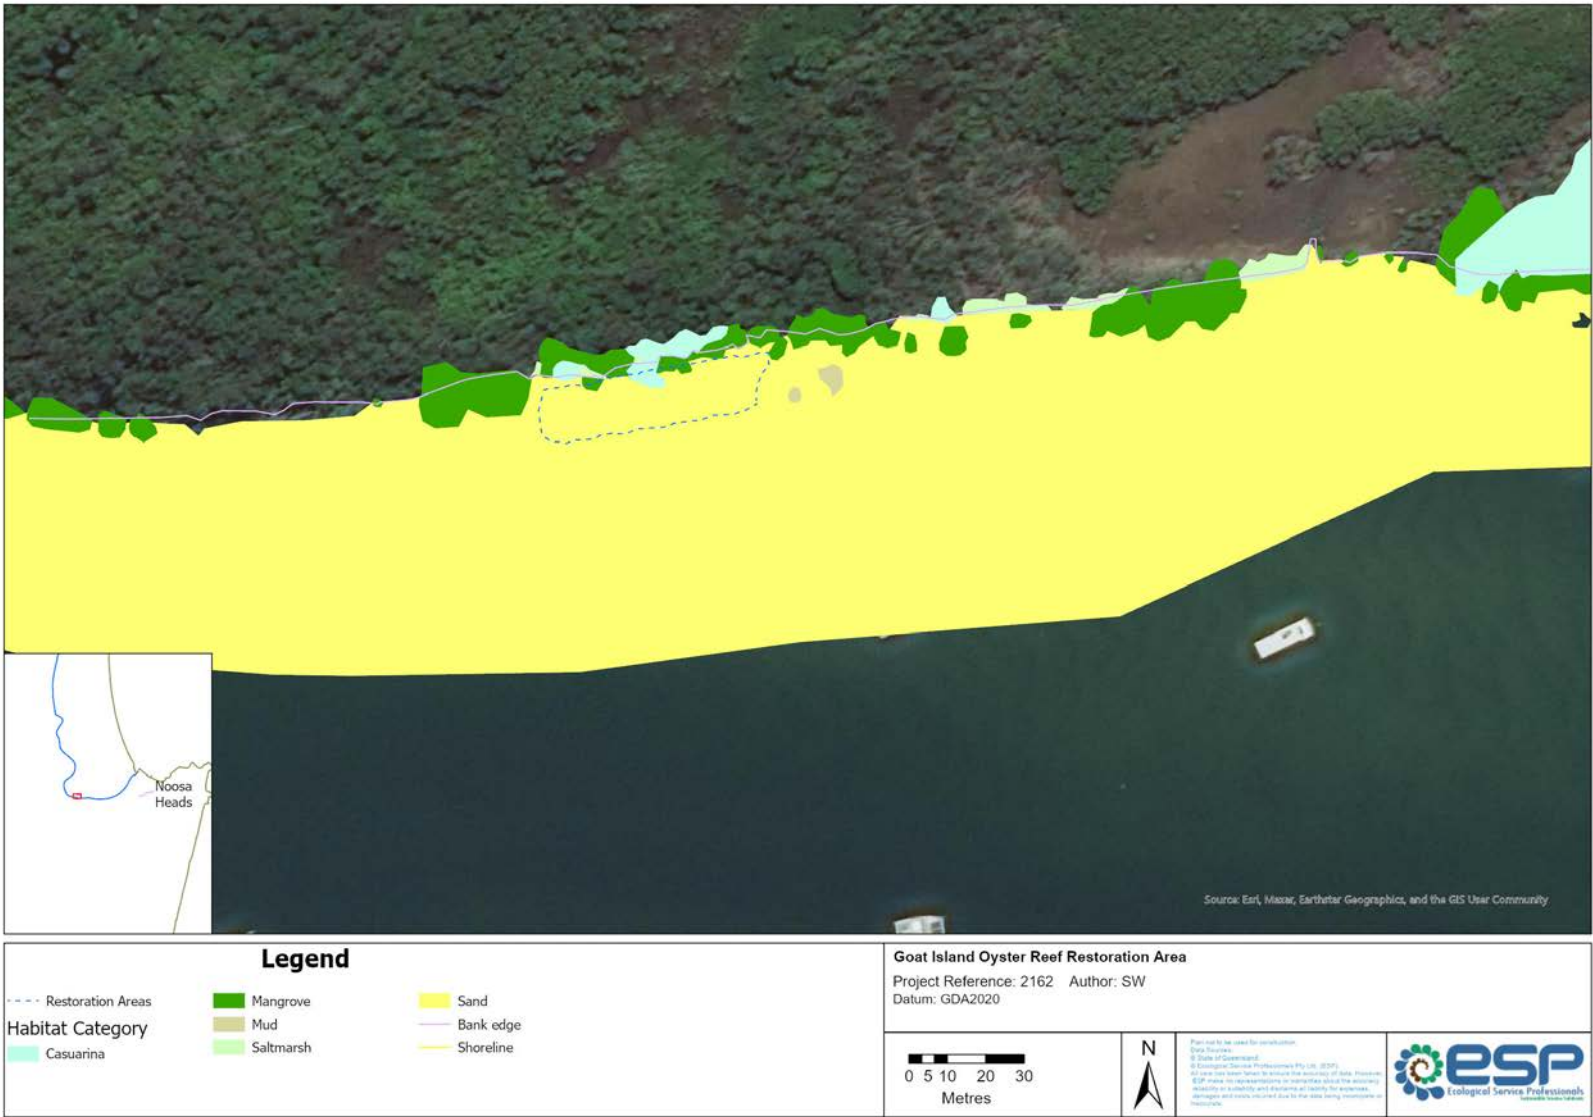
Figure 3.2 Habitat map and shoreline at Goat Island restoration area

Mangroves occurring along the shoreline at the Goat Island and Noosa Sound East restoration areas were incorrectly mapped in ESP 2021, due to a display error. The location of mangroves have subsequently been updated in the maps provided below (Figure 3.2 & Figure 3.3). Note that the full extent of mangroves occurring more than 5 m landward of the shoreline at Goat Island were not mapped in detail as they are unlikely to be impacted by the restoration area.

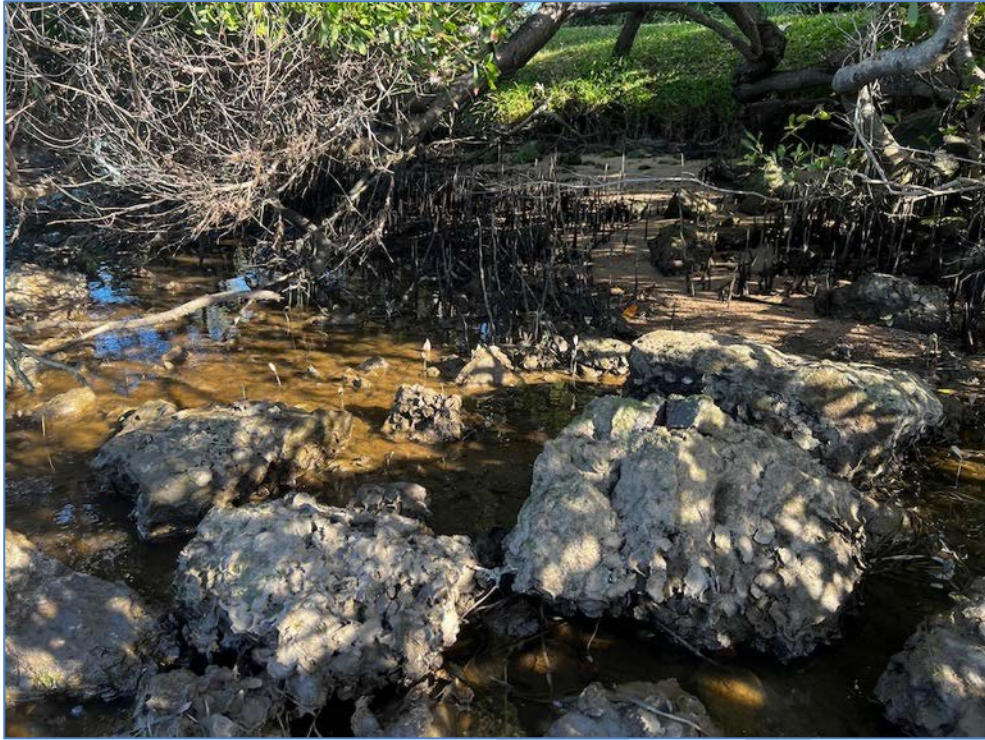
The highest average density of oysters ($15.6 \text{ ind.m}^{-2} \pm 3.0$) was observed at Tewanin (Figure 3.8 & Figure 3.9) and Noosa Sound West ($21.2 \text{ ind.m}^{-2} \pm 6.4$) (Figure 3.11) occurring on narrow intertidal rock and gravel outcrops along the shoreline. Oysters were also observed growing on some mangrove roots adjacent to some restoration areas, although at lower average densities (2 to 8 ind.m^{-2}) (Figure 3.10).

Figure 3.9 Rock oysters growing on rocks at Tewantin

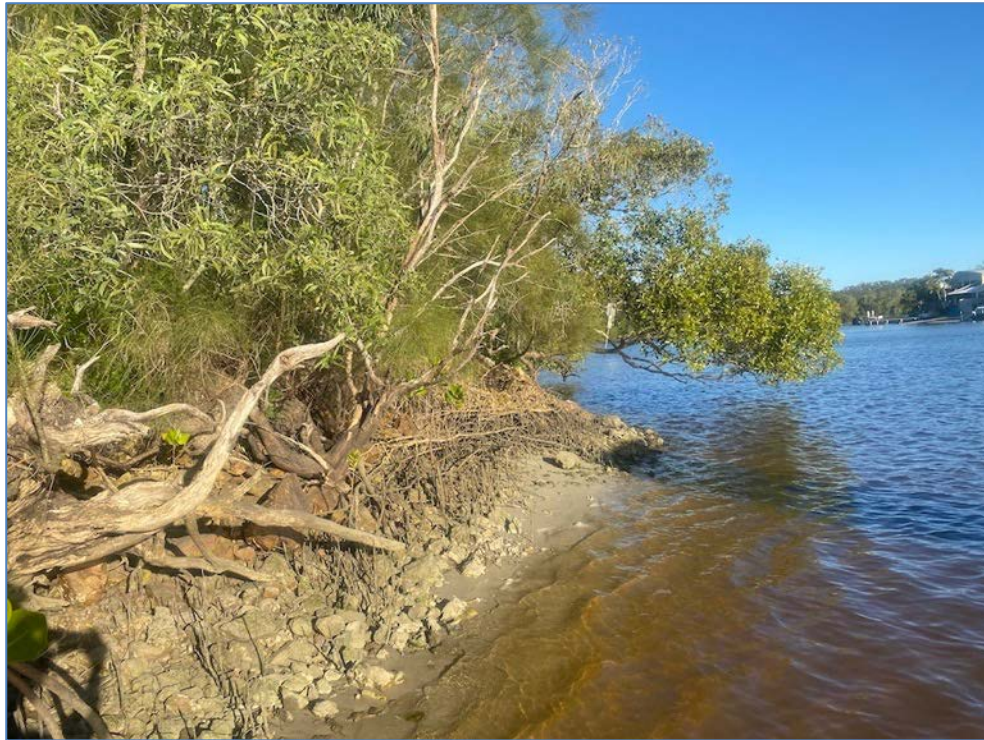
Figure 3.11 Oysters growing on rocky rubble at the mouth of Weyba Creek (adjacent to Noosa Sound West restoration area)

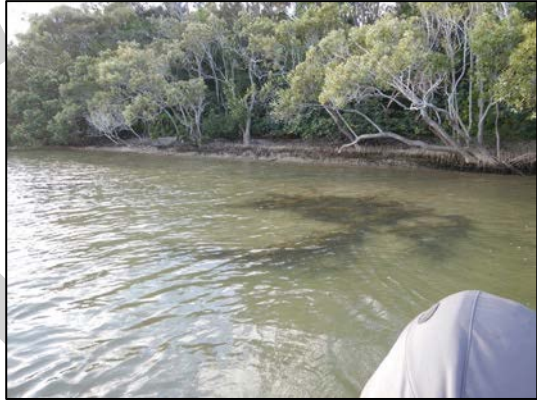
<p>Dense but small patch of <i>Zostera</i> (<30m²) upstream of the restoration area</p>

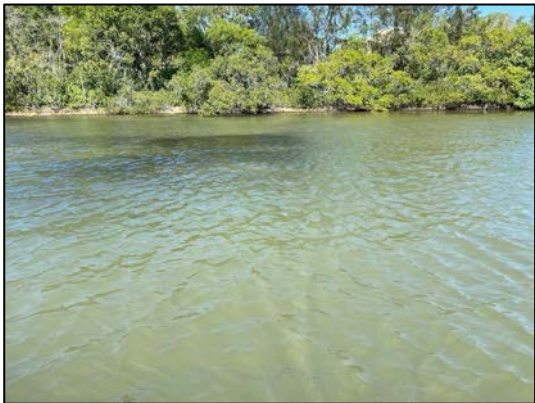
<p>Patchy seagrass at upstream end of investigation area</p>

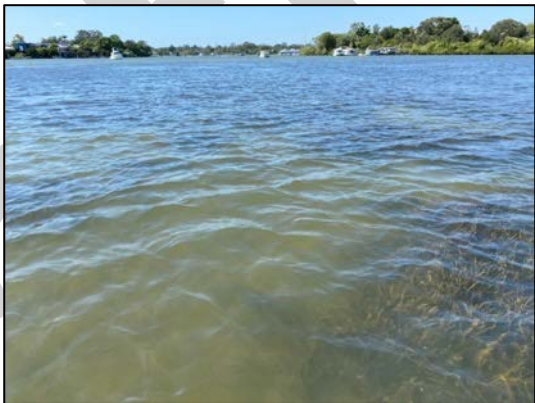
<p>Extensive seagrass bed upstream of investigation area</p>

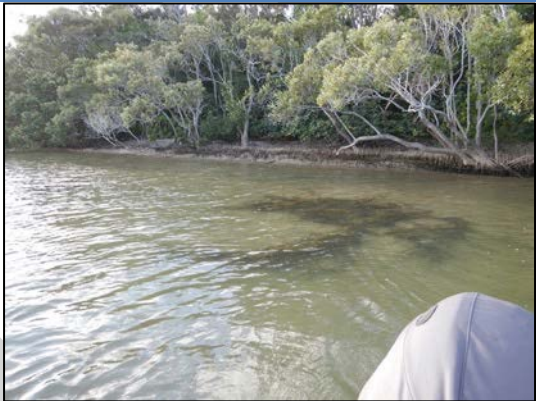
Goat Island	<p>Patchy and narrow fringing mangrove forest between coastal rainforest communities dominated by grey mangrove. Canopy height of 4 to 6 m. Forest extends to a large low canopy forest to the north east of the island, away from the restoration area.</p> <p>The mangroves in this reach are in good condition.</p>

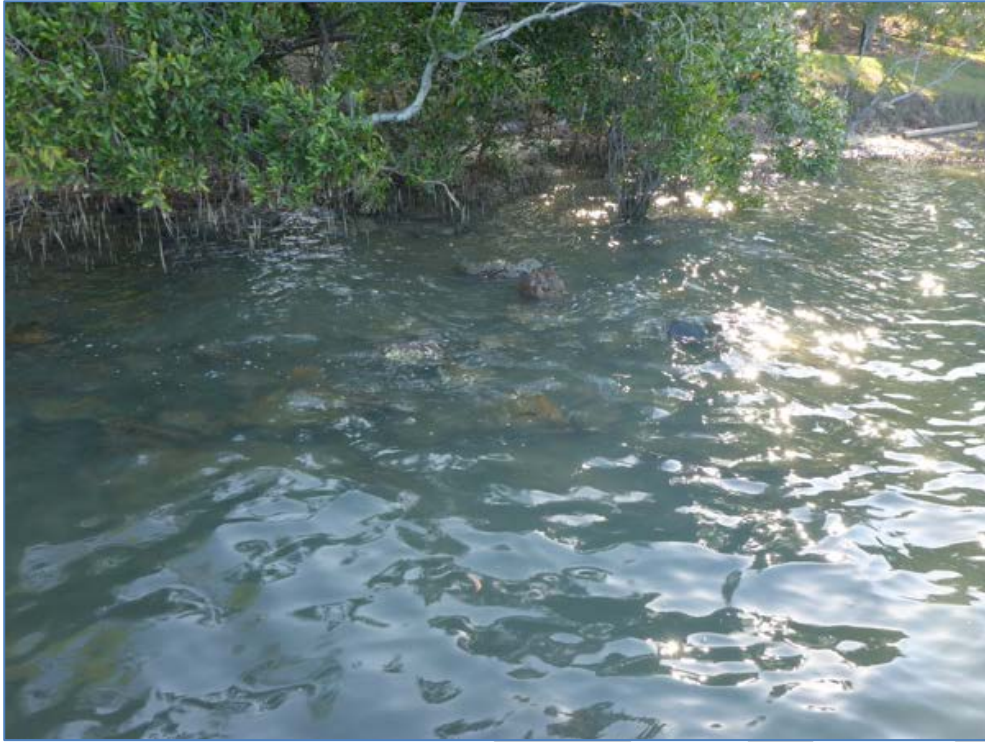
The Tewantin reach has several large areas of gravel with dead oyster shell (Figure 5.3) and rocky rubble (Figure 5.4) that have been buried in places by up to 0.5 m of fine sediment (Figure 5.5), particularly in areas of accretion adjacent to seagrass beds and upstream of the rocky reef surrounding an existing channel marker. In intertidal habitat, oysters aggregated in a narrow band in moderate to low densities on the rock rubble adjacent to the existing mangroves along the bank edge (Figure 5.4). The densest aggregation of oysters were limited to intertidal areas on existing pylons and the rock around jetties. In July 2022, water clarity was extremely poor and we were unable to confirm the presence of subtidal habitats around Tewantin visually. A grappling hook and pole were used to confirm the presence or absence of seagrass and macroalgae at these sites.

Figure 5.4 Narrow area of rock rubble with rock oysters adjacent to council chambers with narrow band of grey mangroves further landward in 2020

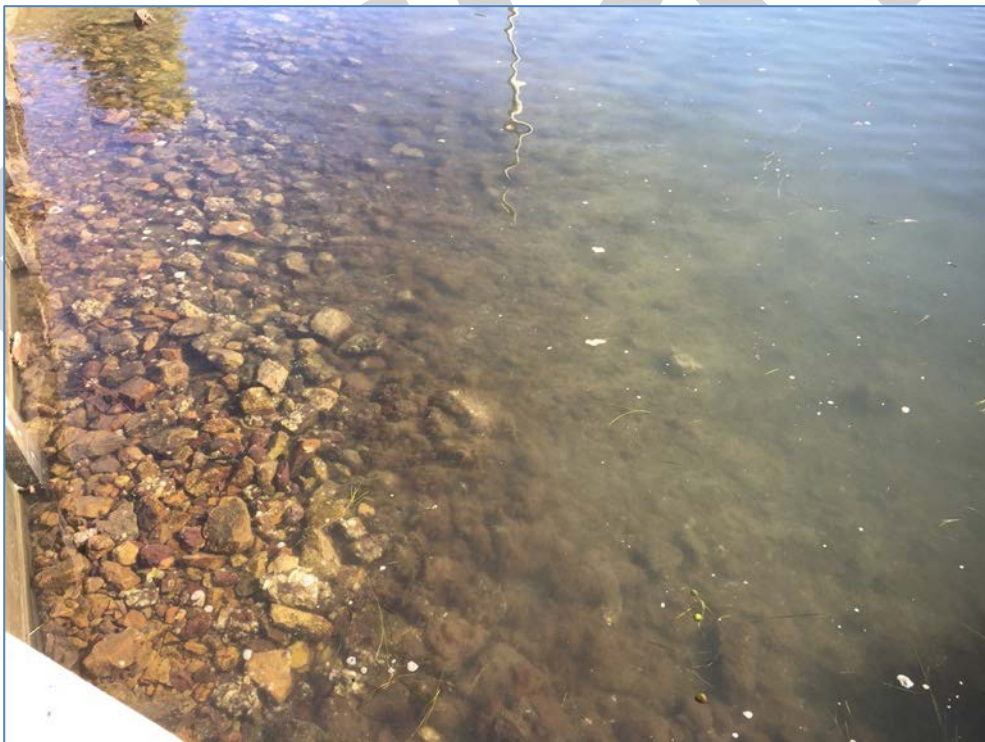
Figure 5.5 Intertidal rock rubble and gravel adjacent to the existing boat ramp and jetty in 2020

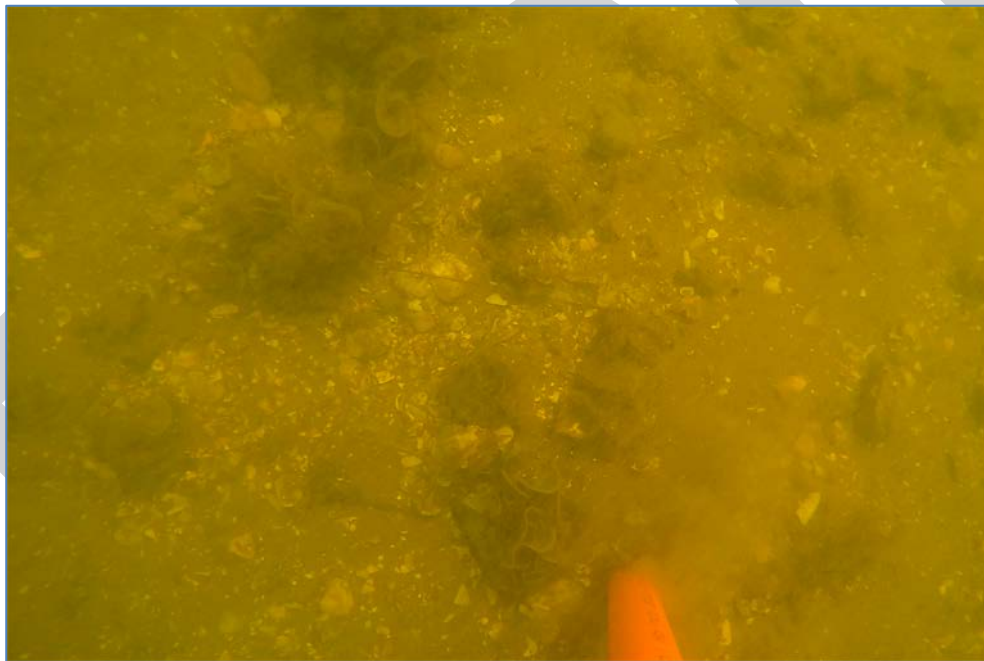
In subtidal areas, exposed rock surfaces had a high coverage of fine algal turf that trapped a thick sediment layer. Macroalgae growing on rocks was dominated by *Padina* sp., particularly in shallow subtidal areas along the edge of the existing navigation channel and around the existing channel marker (Figure 5.6). These species were generally restricted to subtidal areas and cover was typically sparse (less than 15% of the surface area), particularly in rocky areas close to the shoreline (Figure 5.6). There was a small section of more substantial rocky reef with high vertical relief around the existing channel marker sign, where the densest aggregation of macroalgae (<30% cover) occurred (Figure 5.8). There was also denser macroalgae growing on rubble at the edge of the main river channel and also south of the existing boat ramp adjacent to the bathing area and marina (Figure 5.9). The macroalgal assemblages were in relatively poor condition due to high sediment loads observed on and around the existing rocky reef and rubble areas, with some sections of reef having a high coverage of fine sediment (Figure 5.10).

Figure 5.6 Sparse macroalgae (*Padina* sp.) growing on rock at Tewantin

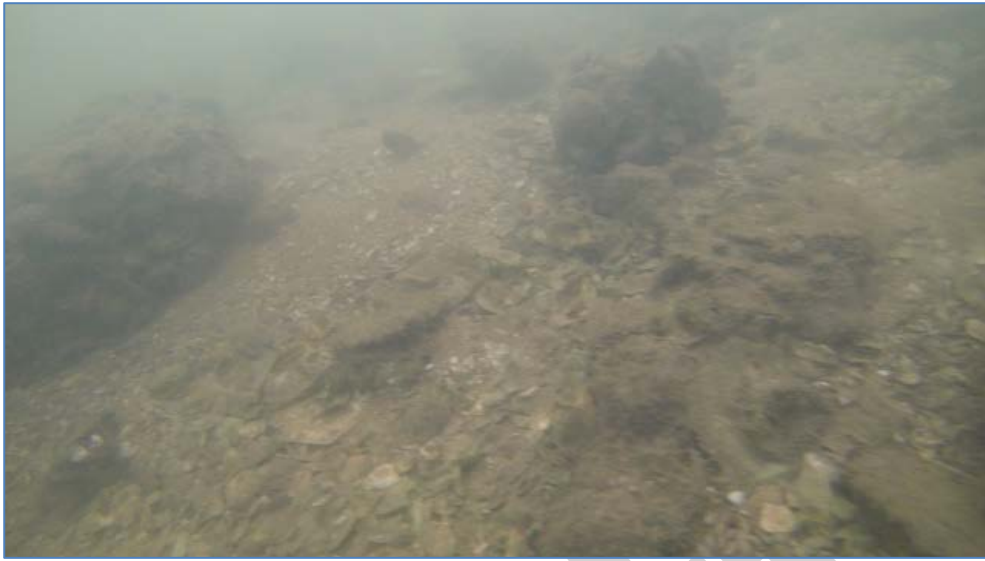
Figure 5.7 Turfing algae and oysters on rocky rubble at the edge of the main river channel with gravel and shell grit between rocks

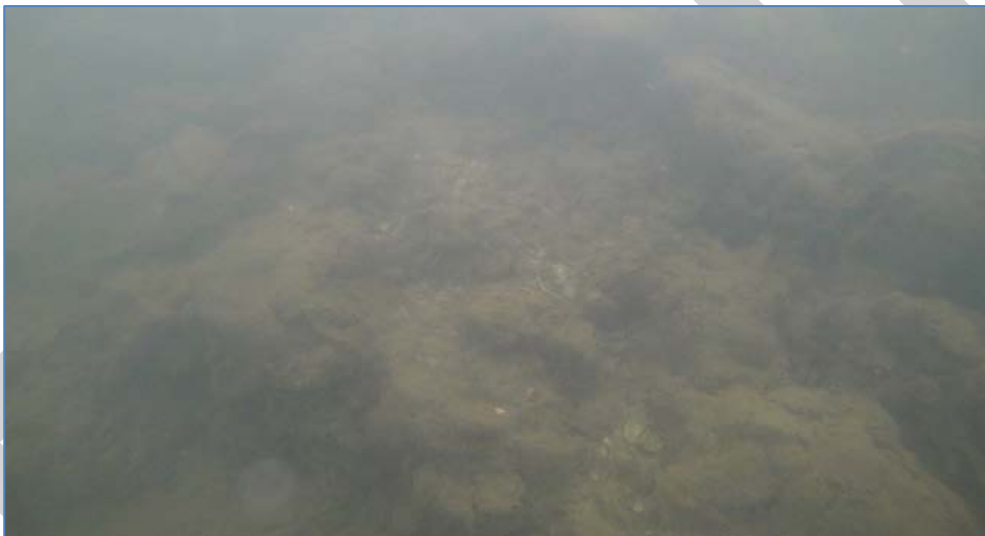
Figure 5.8 High relief rocky reef at existing channel marker with aggregation of oysters and turf algae over surface of rocks

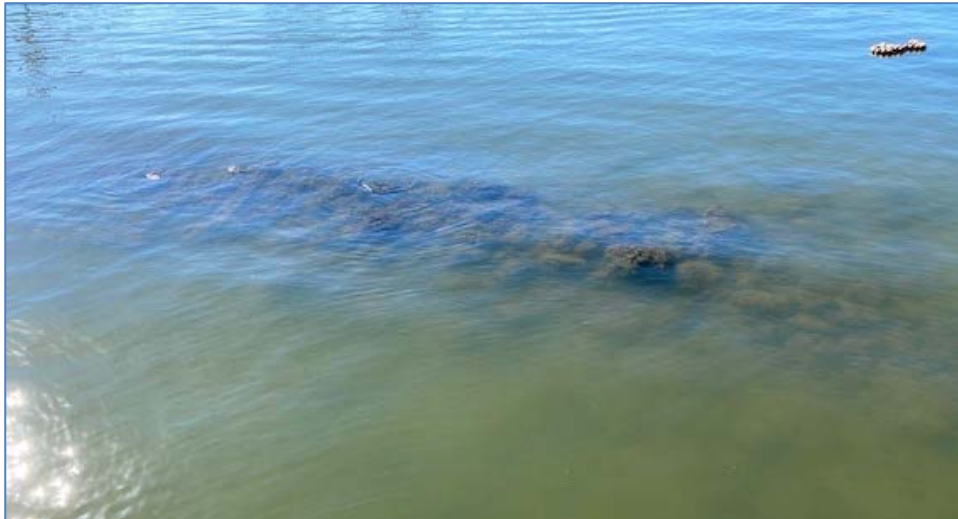
Figure 5.9 Rocky reef with oysters and macroalgae to the south of the investigation area seaward of Tewanin baths

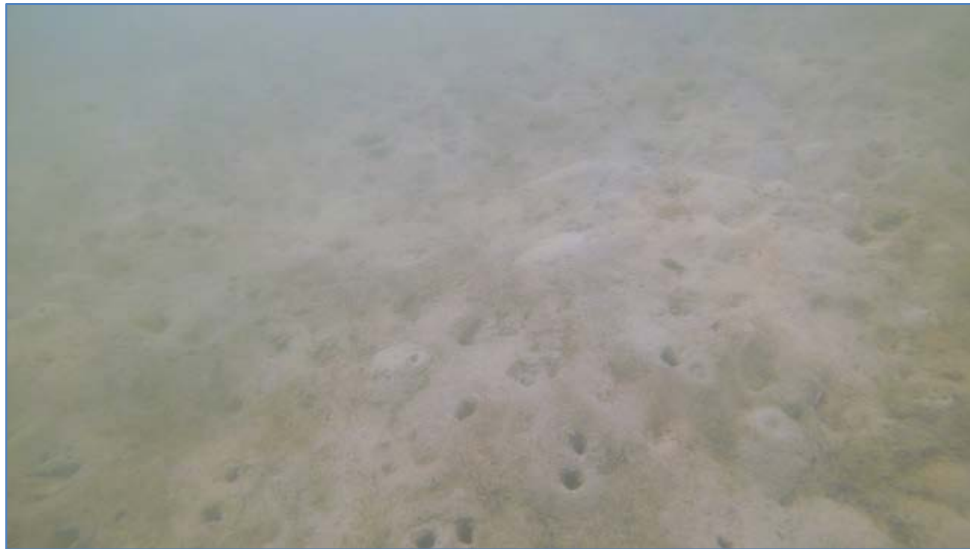
Figure 5.11 Bare sand with sparse yabby burrows in Noosa Sound

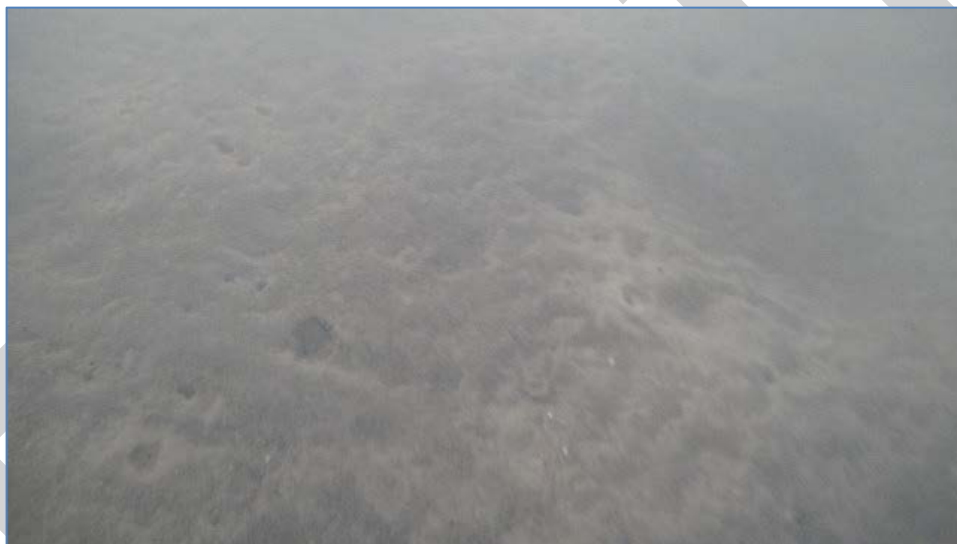
Figure 5.12 Bare sand adjacent to Goat Island
